**Oxidative Degradation of High Density Polyethylene Pipes from
Exposure to Drinking Water Disinfectants**

ESI File No.: 29261A

Impact of Polyethylene Pipe Oxidative Degradation on Pipeline Performance:
A Literature Review – Section I

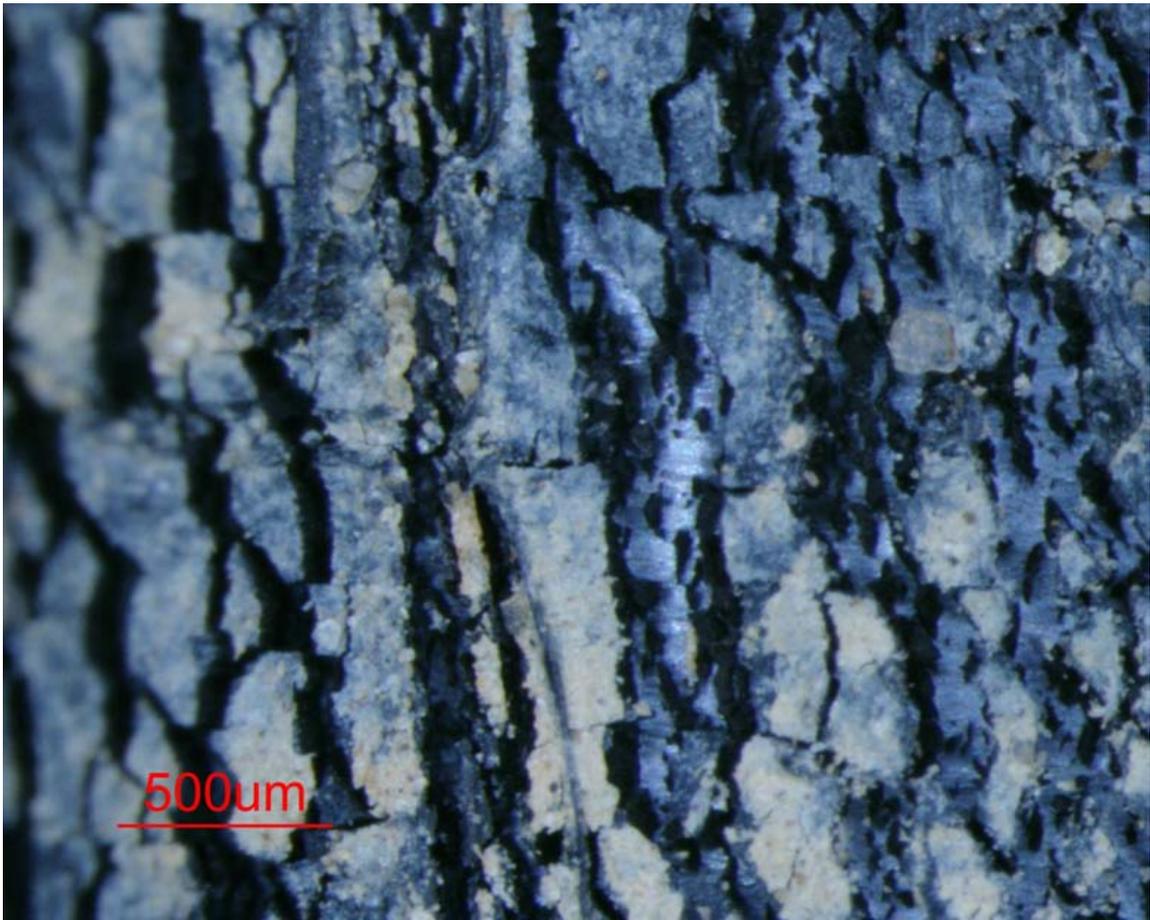
However, the results to date are identical to those observed in some of the research being carried out in Europe (59, 61). Results on HDPE pipe field failure specimens provided by water utility companies in the United States have yielded results similar to that shown in Photograph 3.

When subjected to a modification of the reverse bend back test of ASTM D2513 (59, 61), the inside surface of these pipes cracks extensively as seen in the photo. Thermal analysis of the inside surface layers reveal essentially no antioxidant left in that layer. Infrared spectroscopy of the first 0.002 inch layer inward from the inside surfaces of these samples confirms that the surface layers are oxidized. Full results of the laboratory examination of these field returns are published in Section II of this study.

Photograph 3: Inside surface of in-service leaking HDPE pipe after reverse bend back test.

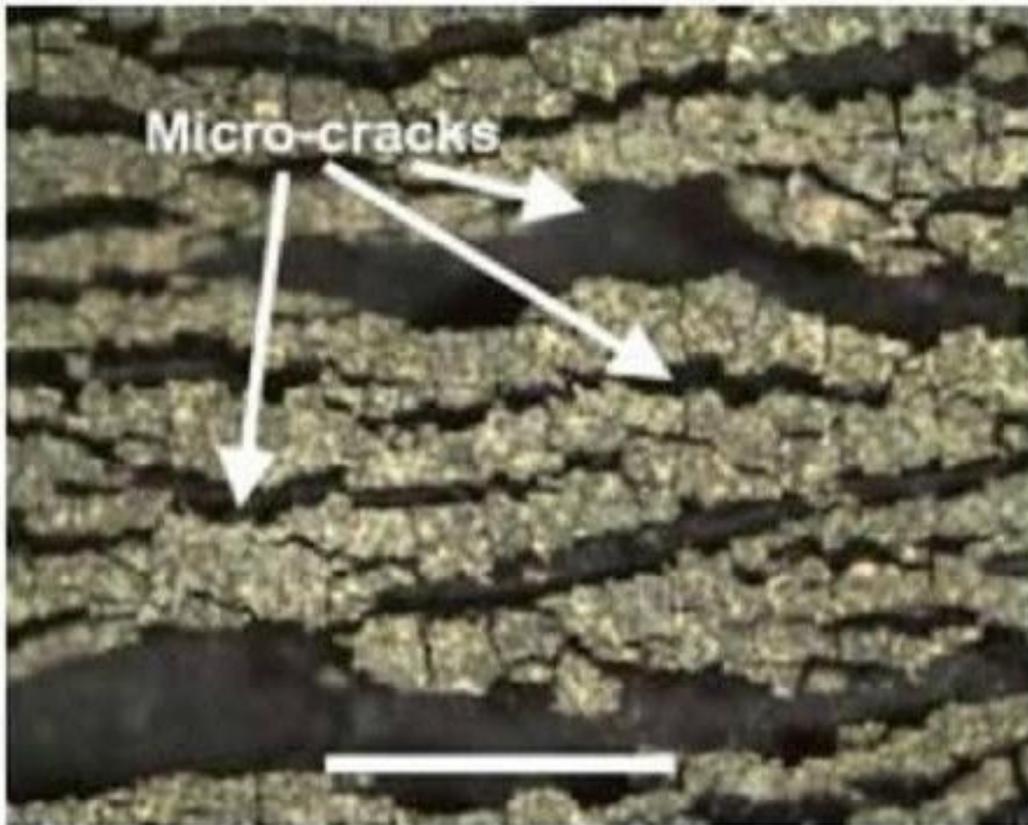
Figure 7: Typical micro-cracking after RBBT

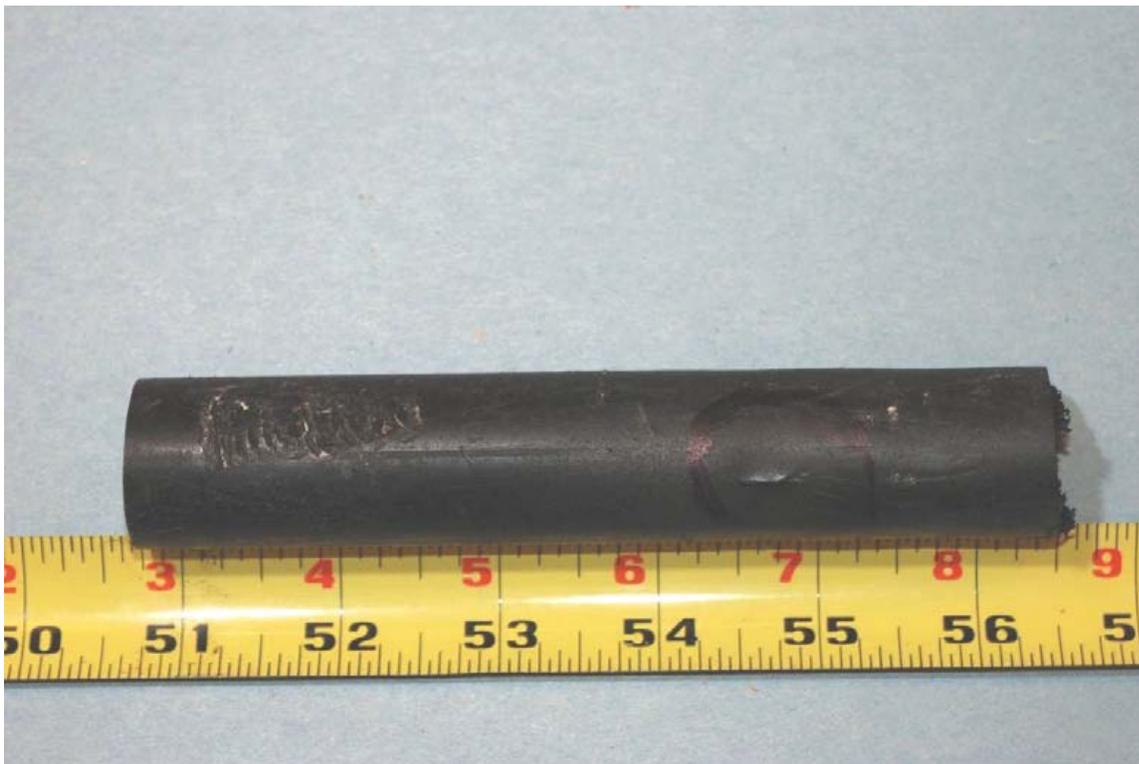
The pipe was apparently squeezed off near the failure site. This may have occurred after the failure. The pipe has cracks at the leak site and opposite the leak, indicating that the pipe was squeezed, leading to some of the cracking (see Figures 3 through 5). The inner surface of the pipe exhibits “mud cracking”, which is typical of severely oxidized material. The material properties have been degraded to such an extent that stresses in all directions cause the material to crack. The depth of this degraded layer is approximately 5 mils thick, leading to multiple crack initiation sites and subsequent slow crack growth as seen in Figures 6 through 10.

This sample has effectively reached the end of its life due to oxidative degradation. At this level of degradation, normal service stresses would lead to fracture, as happened in this case. The level of oxidation has been documented by FTIR, with C.I. values exceeding 0.1 through 5 mils, OIT values near zero at the inner surface and substantial reduction of anti-oxidant in the core.

Figure 1. 3332 Calanda sample, as received.

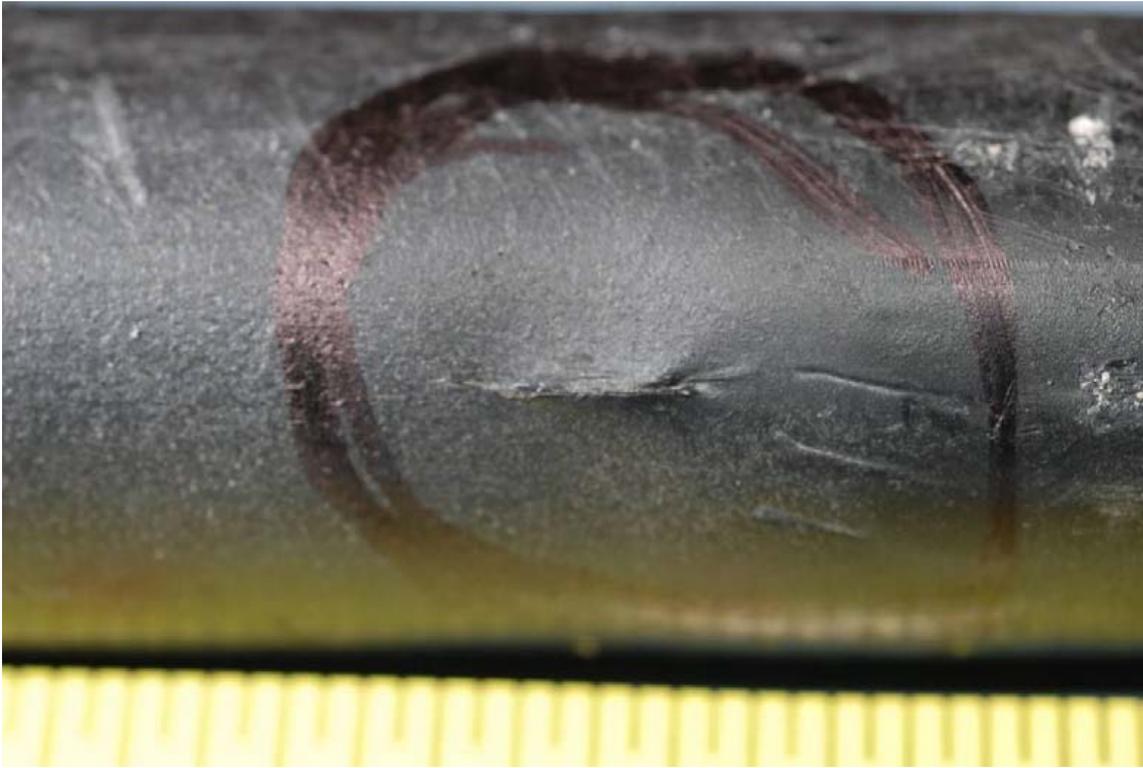
Figure 2. View of longitudinal slit on outer surface of sample.

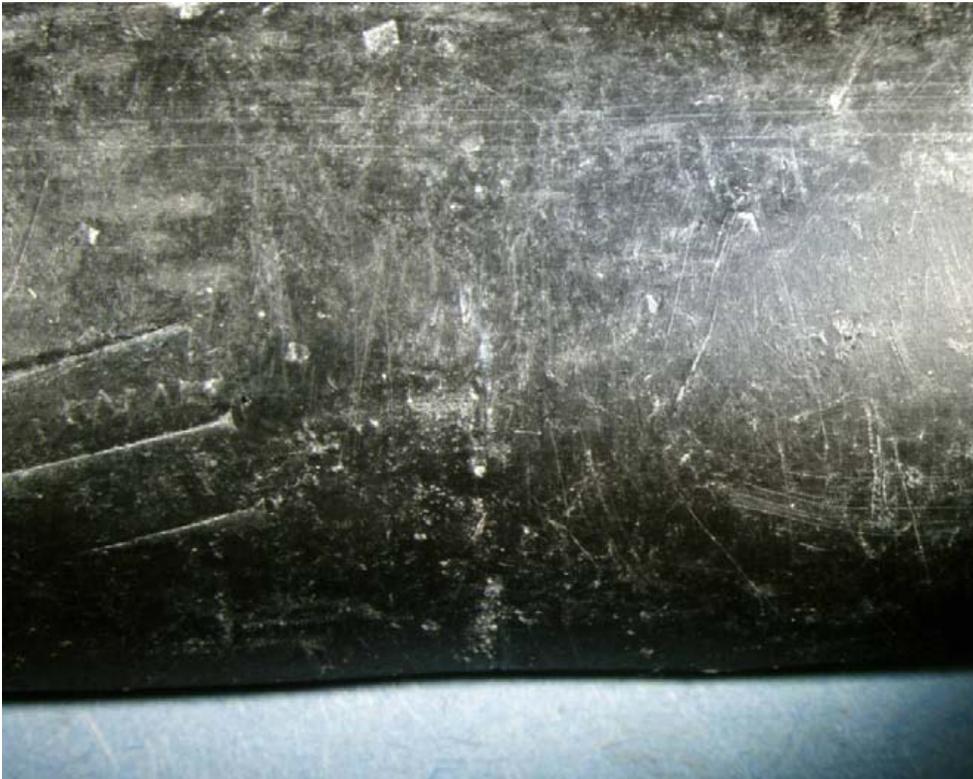
Figure 3. Squeeze-off adjacent to failure location.

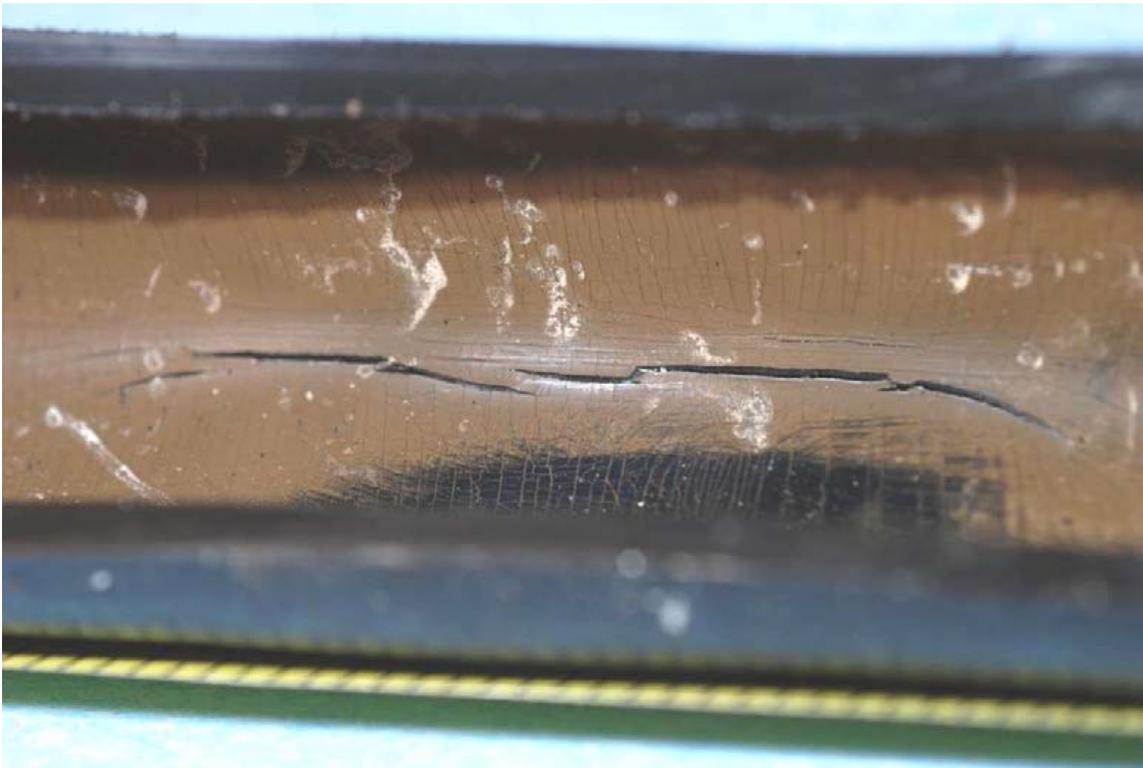
Figure 4. Inner surface view of fracture.

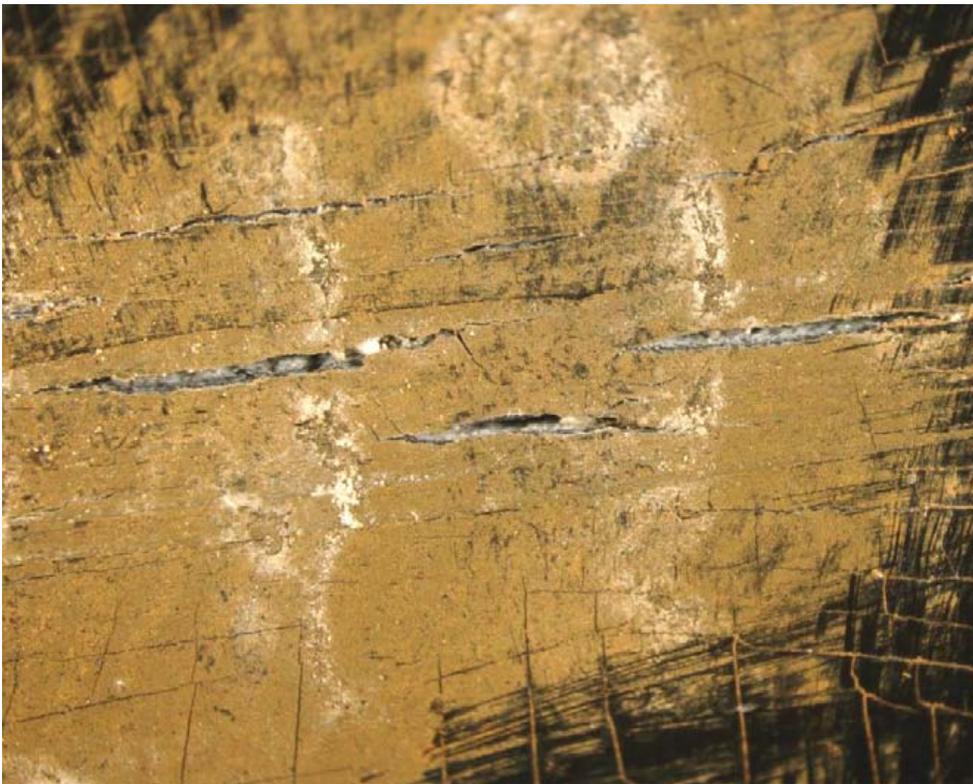
Figure 5. Partial crack opposite the leak site.

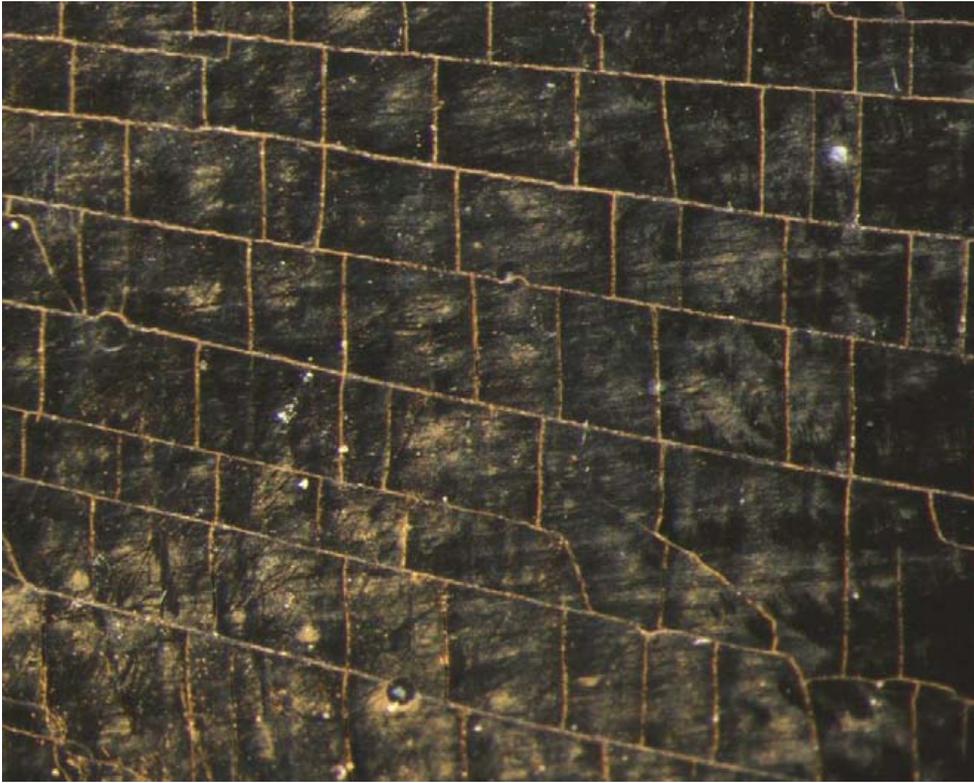
Figure 6. Multi-axial cracks on the inner surface away from the failure site.

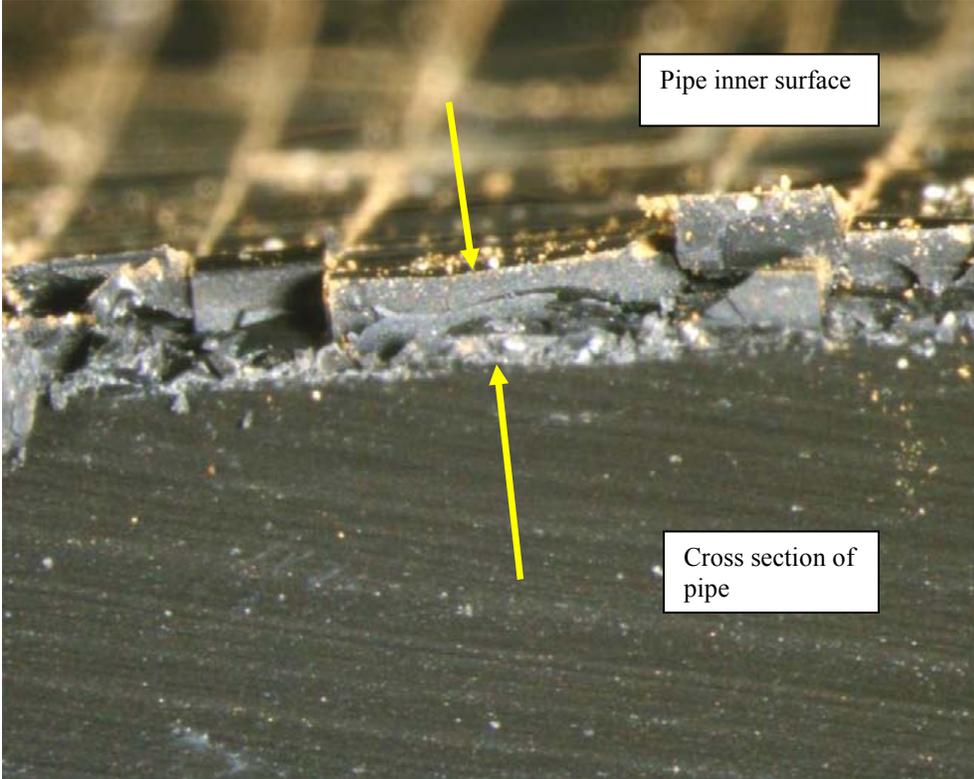
Figure 7. Thick degraded layer on inner surface of failed pipe.

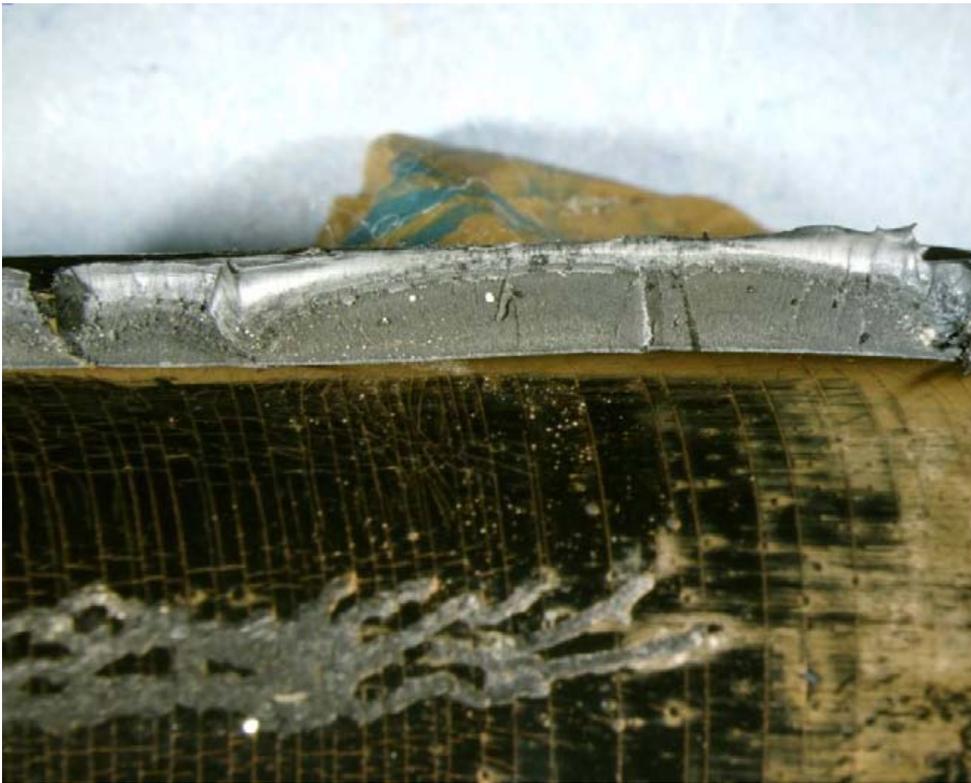
Figure 8. Fracture surface showing multiple initiation sites along the inner surface.

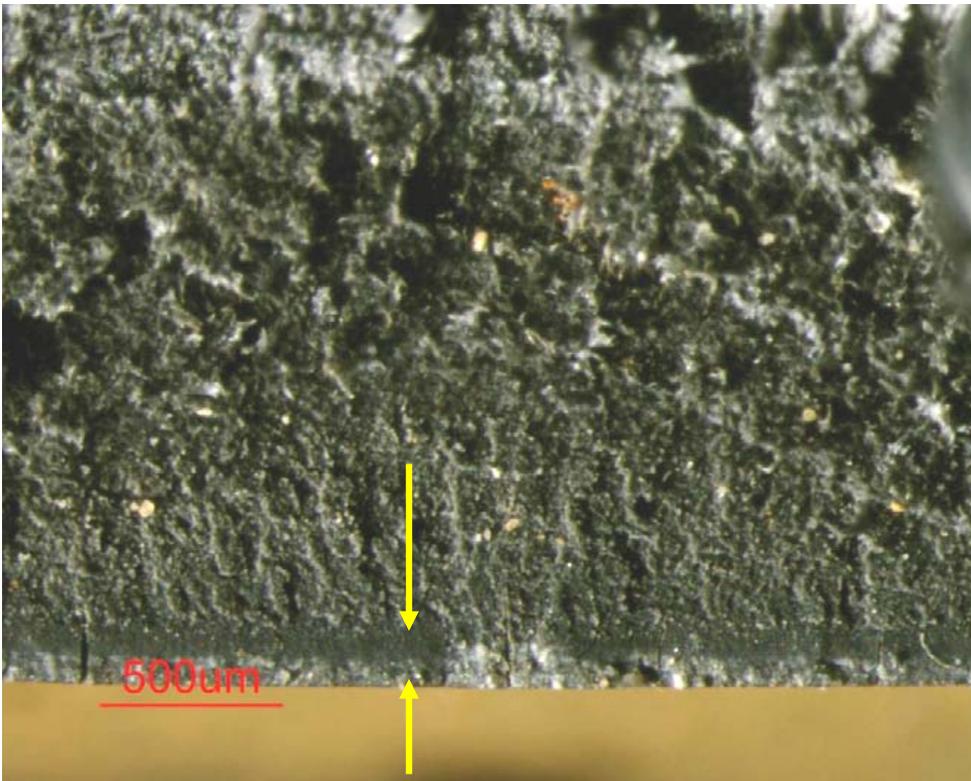
Figure 9. Close-up of a fracture origin showing degraded layer.

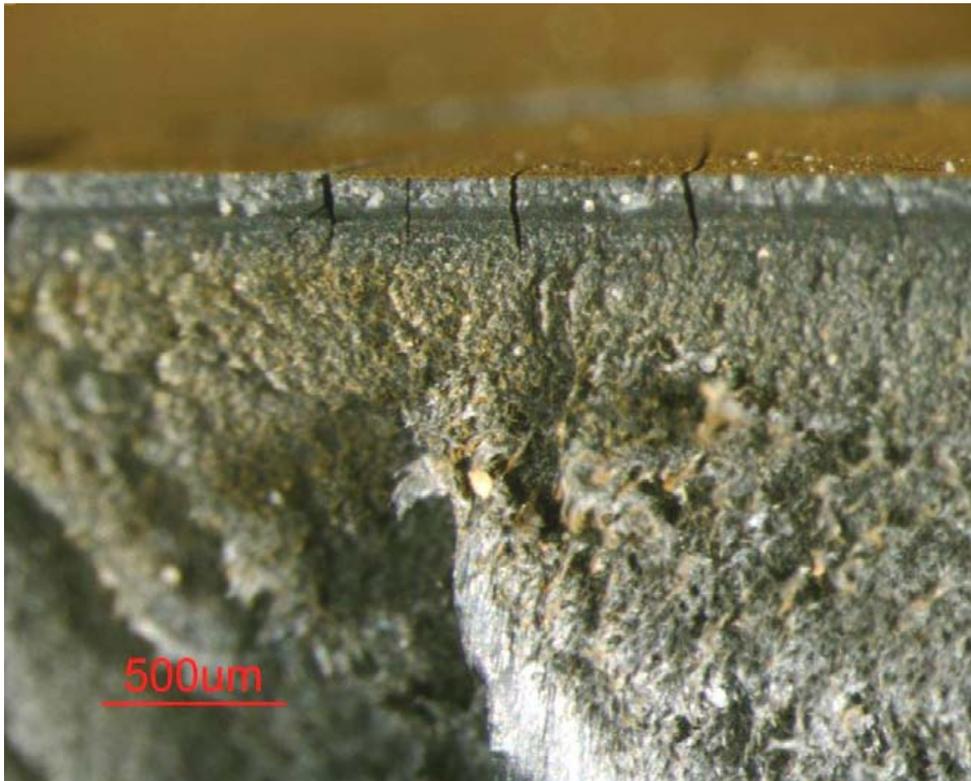
Figure 10. Fracture surface from an adjacent area showing brittle inner surface.

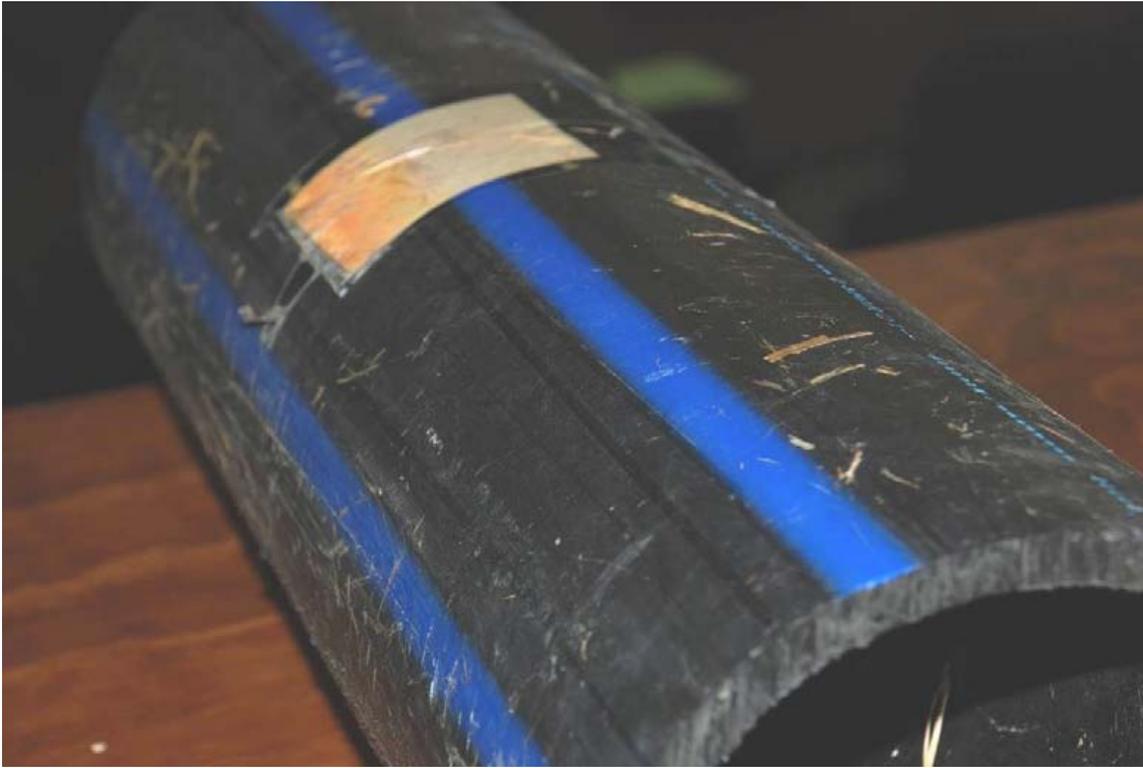
This pipe had failed after only 5 years in service, and exhibited cracking at various locations around the circumference. The sample is shown in Figures 11 and 12, as received. The sample was sectioned in order to examine the fracture surfaces. Figure 13 depicts the appearance of cracking on the pipe I.D. Figures 14 through 18 are photographs of the fracture surfaces. The large number of fracture origins and location at various locations around the circumference suggest that crack initiation was facilitated by the inner surface oxidation that was detected. These cracks then propagated through the pipe wall by a slow crack growth mechanism, driven by the in-service stresses.

Figure 11. Ocoee 6-inch HDPE pipe sample, as received.

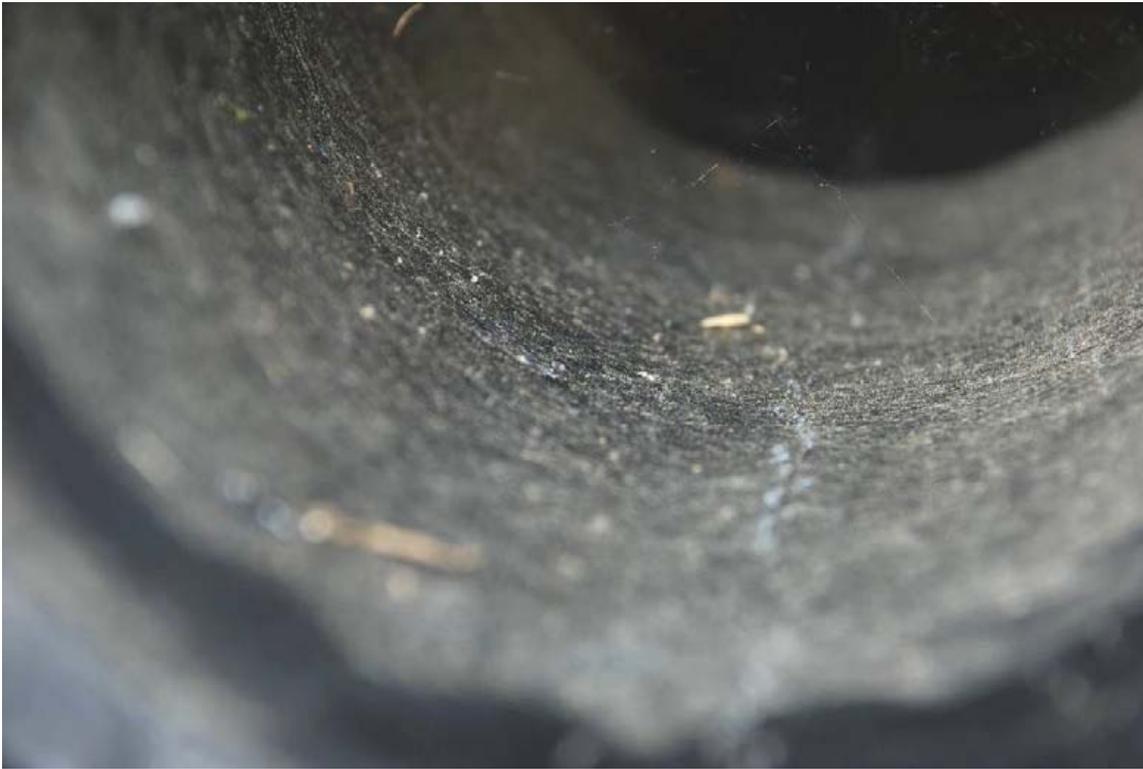
Figure 12. Cracking of Ocoee sample on Pipe I.D.

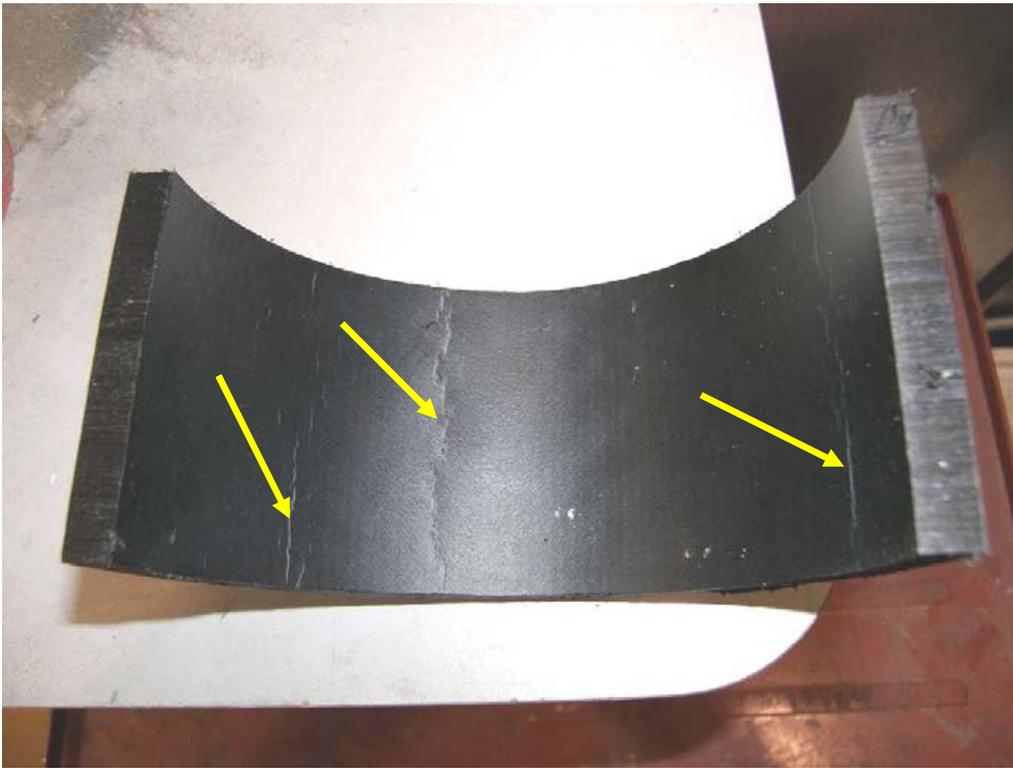
Figure 13. Cracking visible on the inner surface of the pipe I.D.

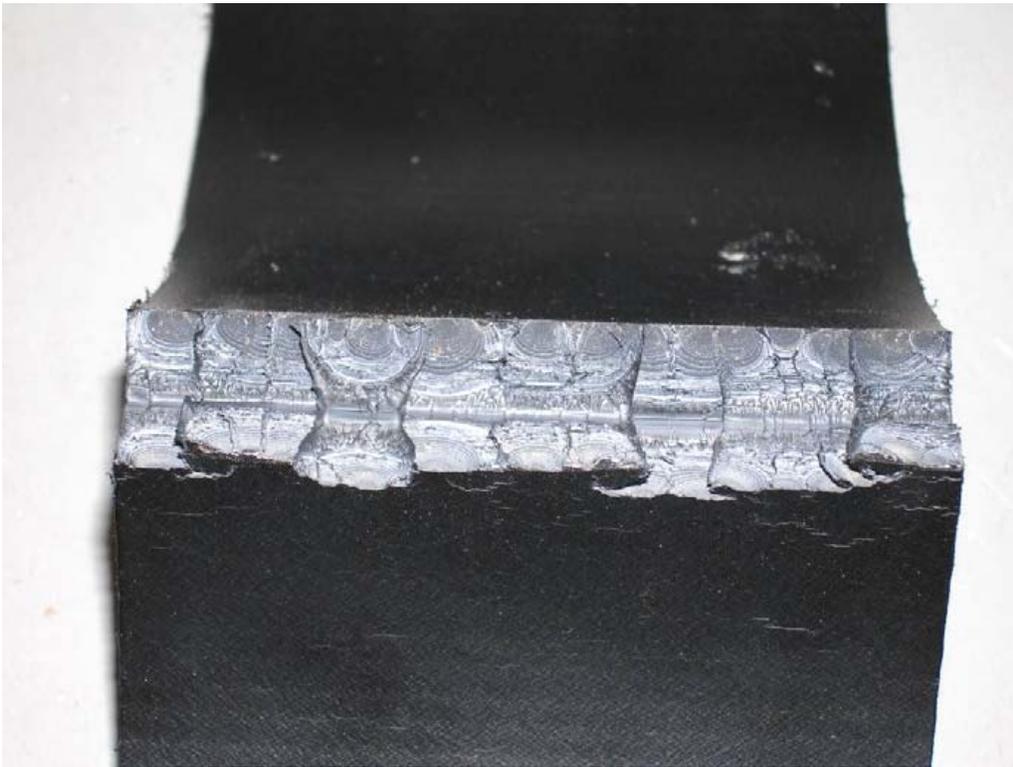
Figure 14. Exposing the fracture surface - Ocoee sample.

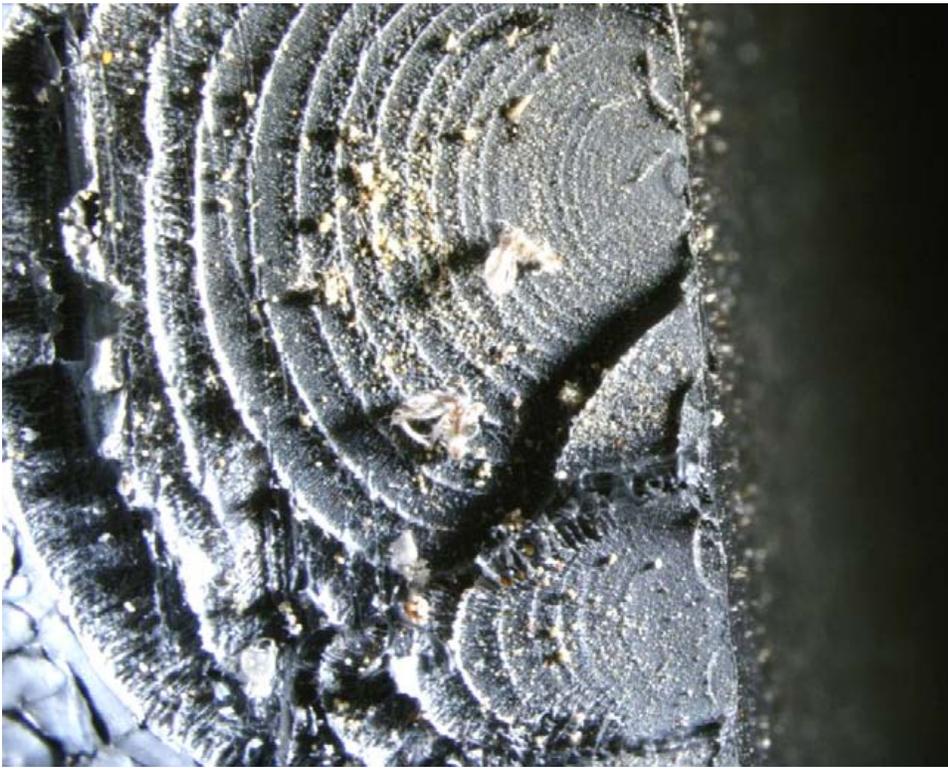
Figure 15. A portion of the fracture surface showing multiple fracture origins and slow crack growth.

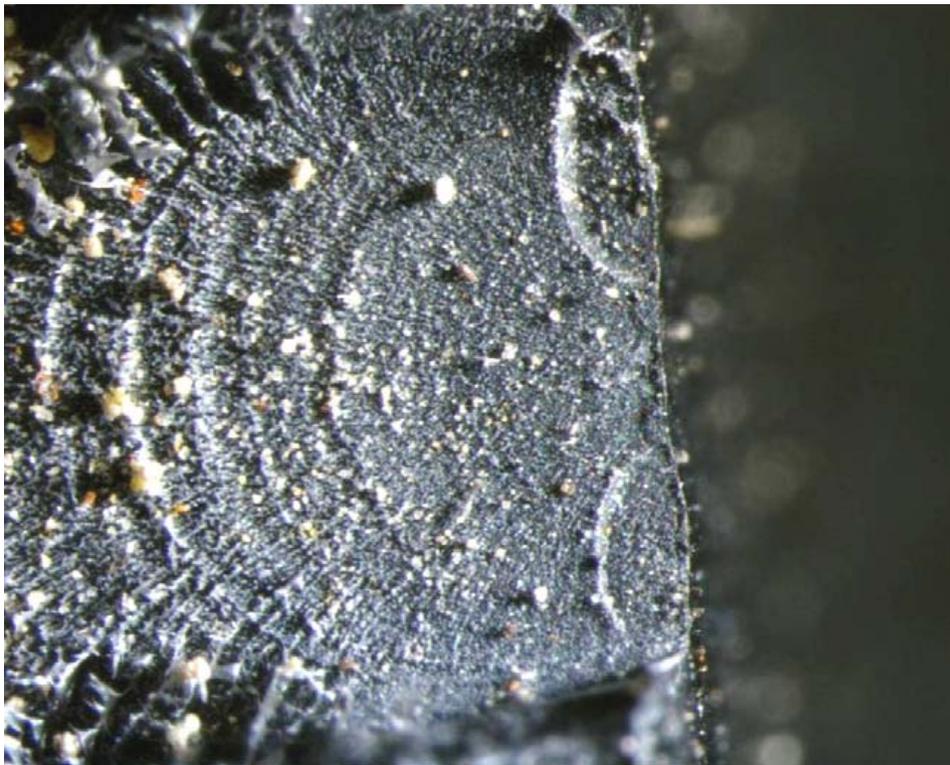
Figure 16. Close-up of fracture surface showing slow crack growth progression.

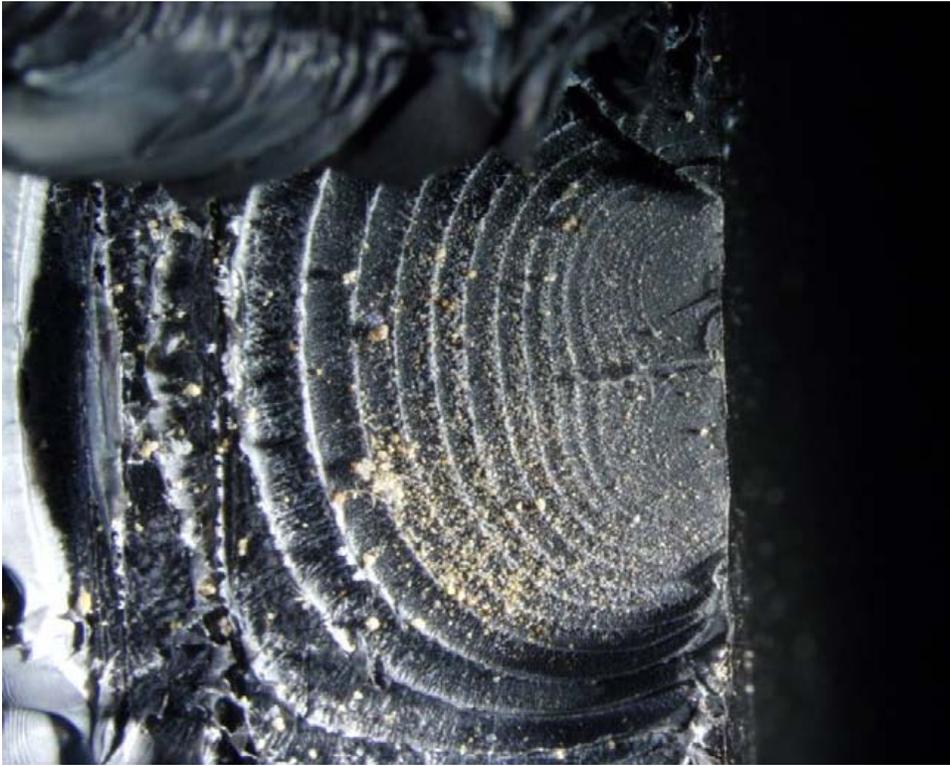
Figure 17. Adjacent fracture origin area.

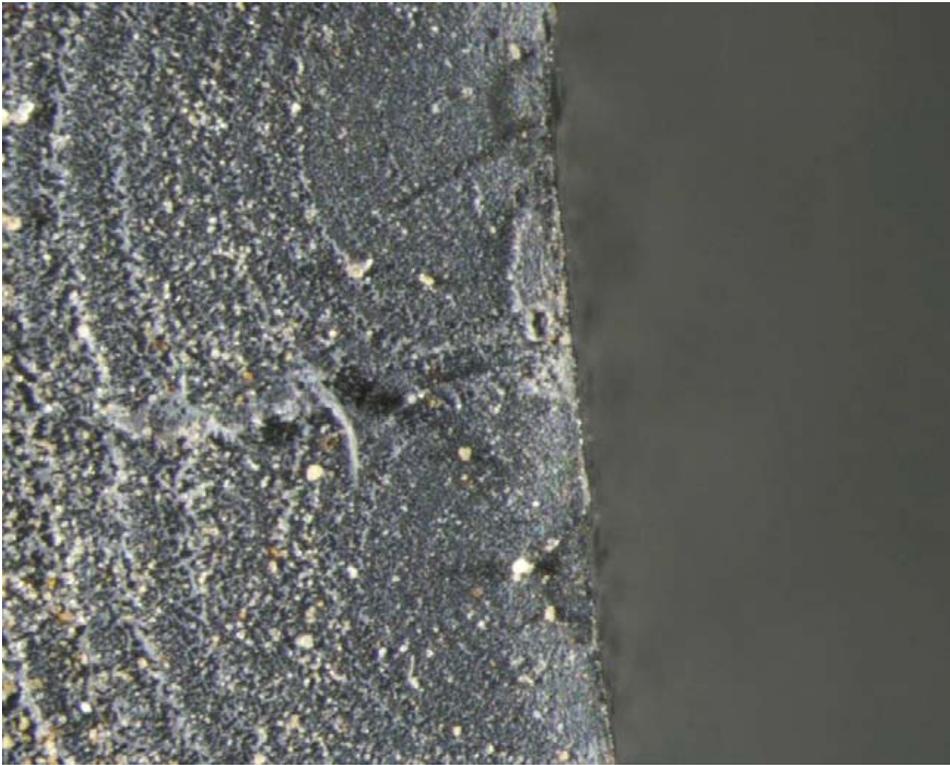
Figure 18. Close-up of fracture origins.

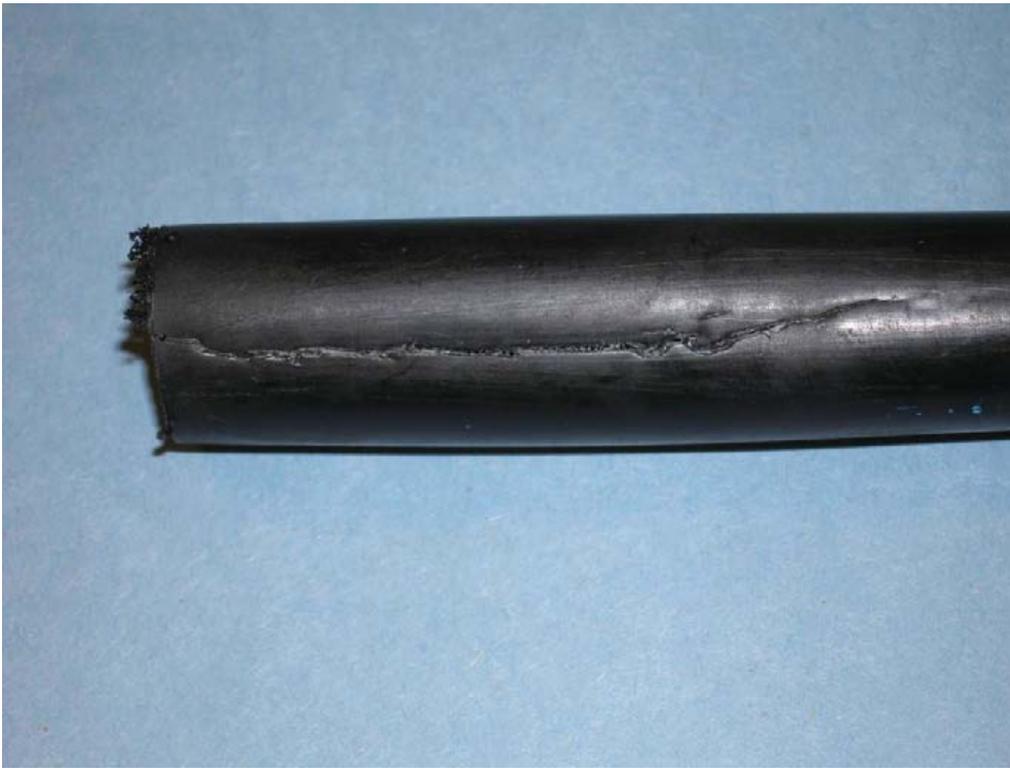
Figure 19. Longitudinal fracture from 5612 Anise CT, Bakersfield, CA .

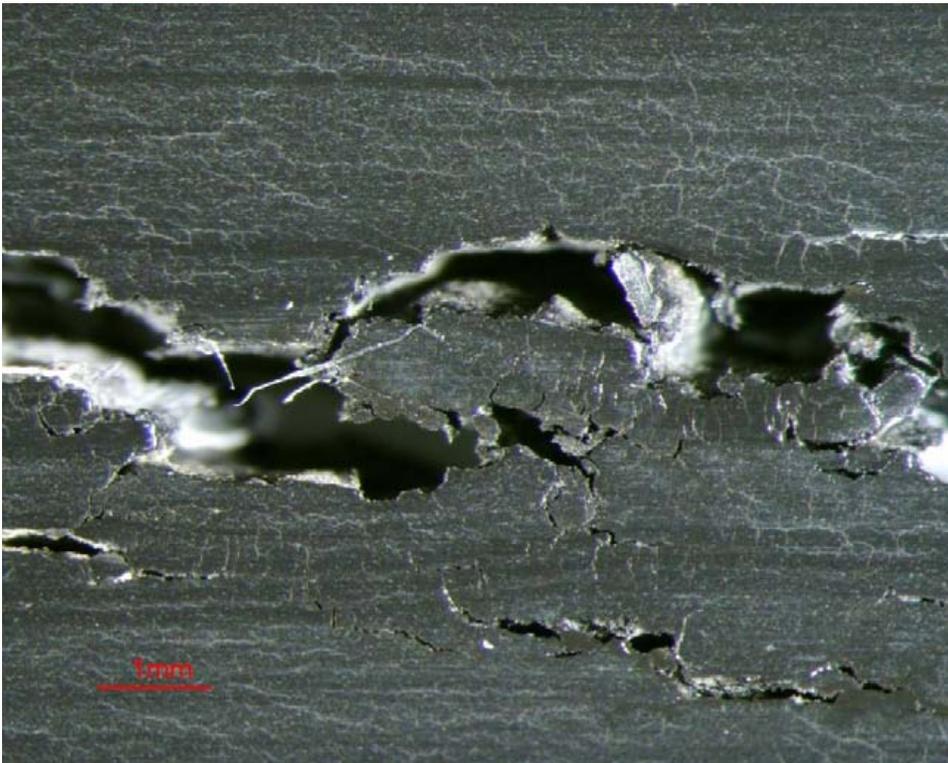
Figure 20. Inner surface view of fracture – 5612 Anise CT, Bakersfield, CA.

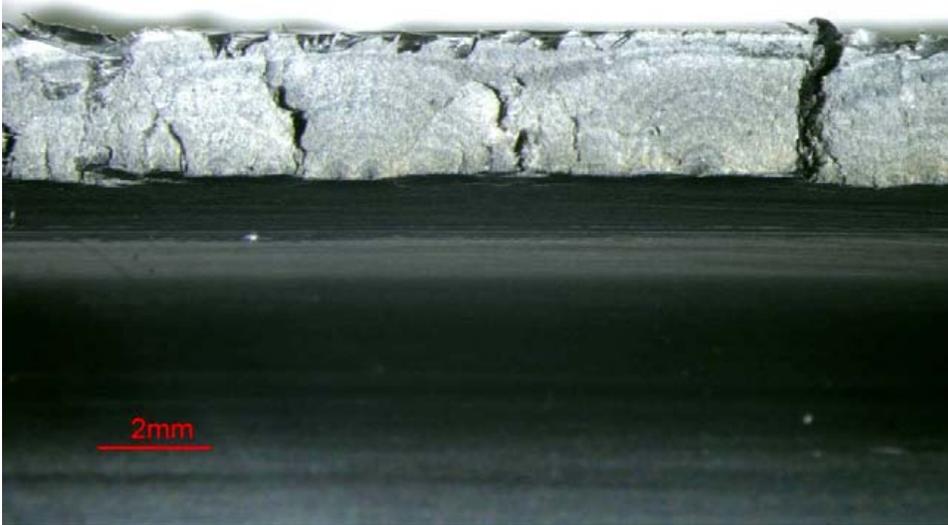
Figure 21. Fracture surface from 5612 Anise CT with multiple origins at I.D.

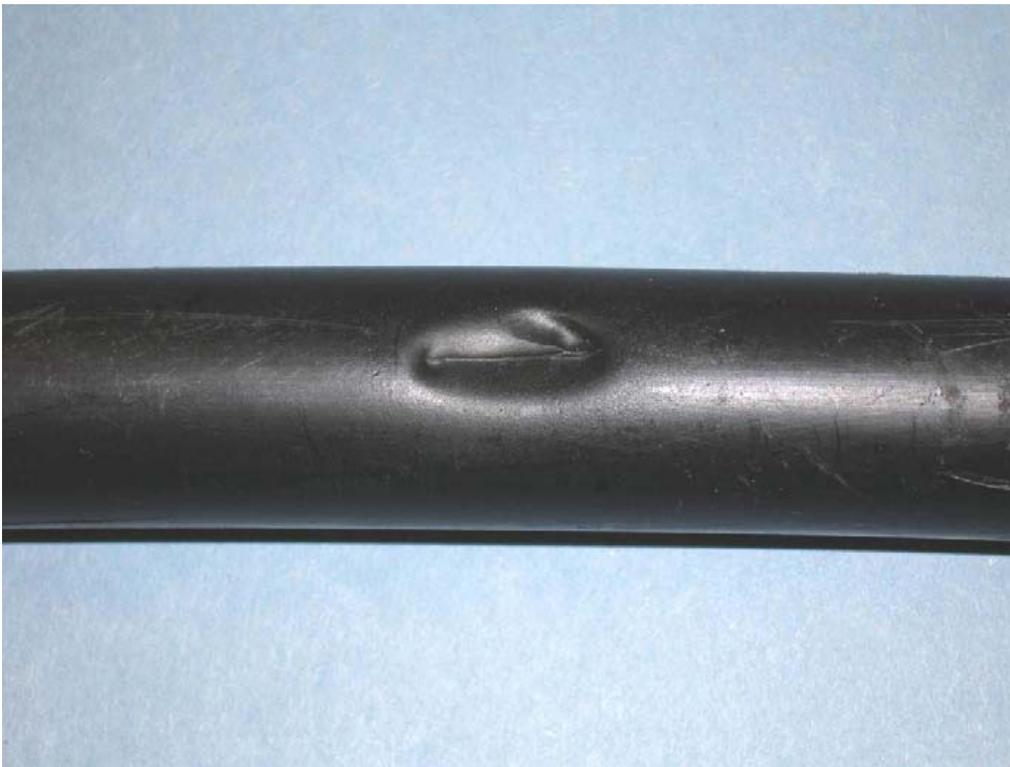
Figure 22. Bakersfield failure sample.

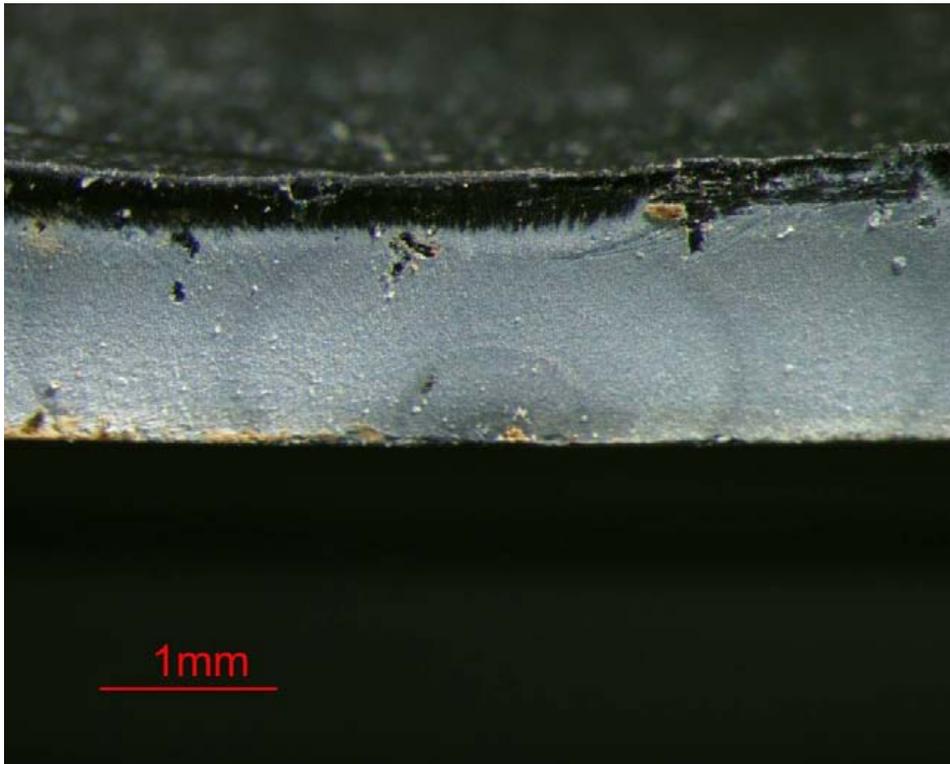
Figure 23. Apparent rock impingement fracture surface from Figure 22.

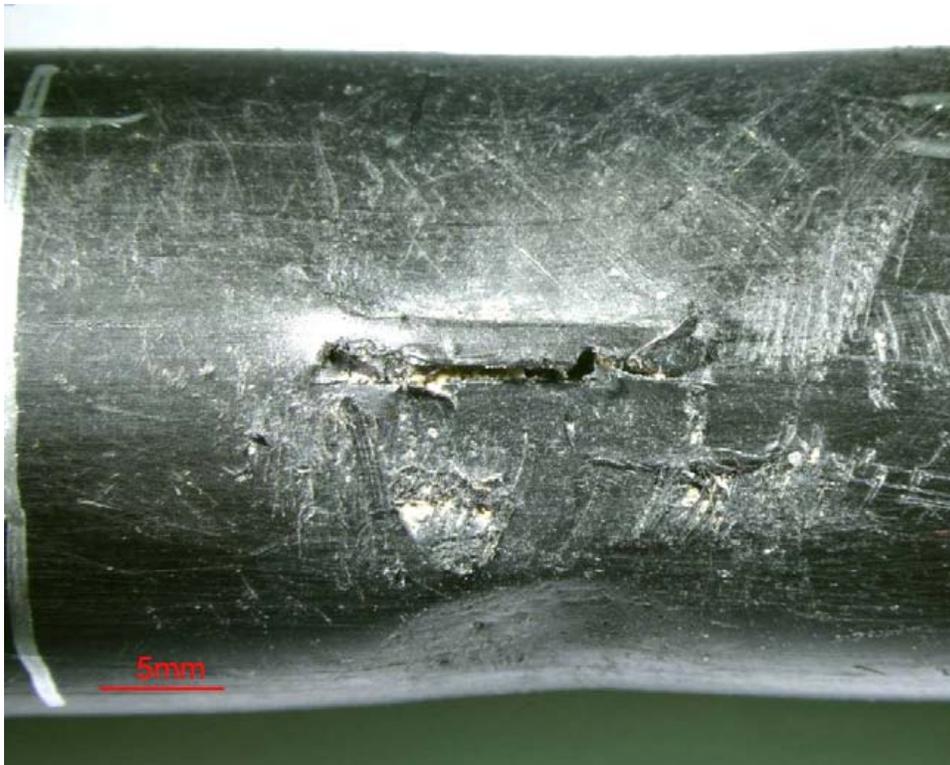
Figure 24. Failure at a squeeze-off – Bakersfield.

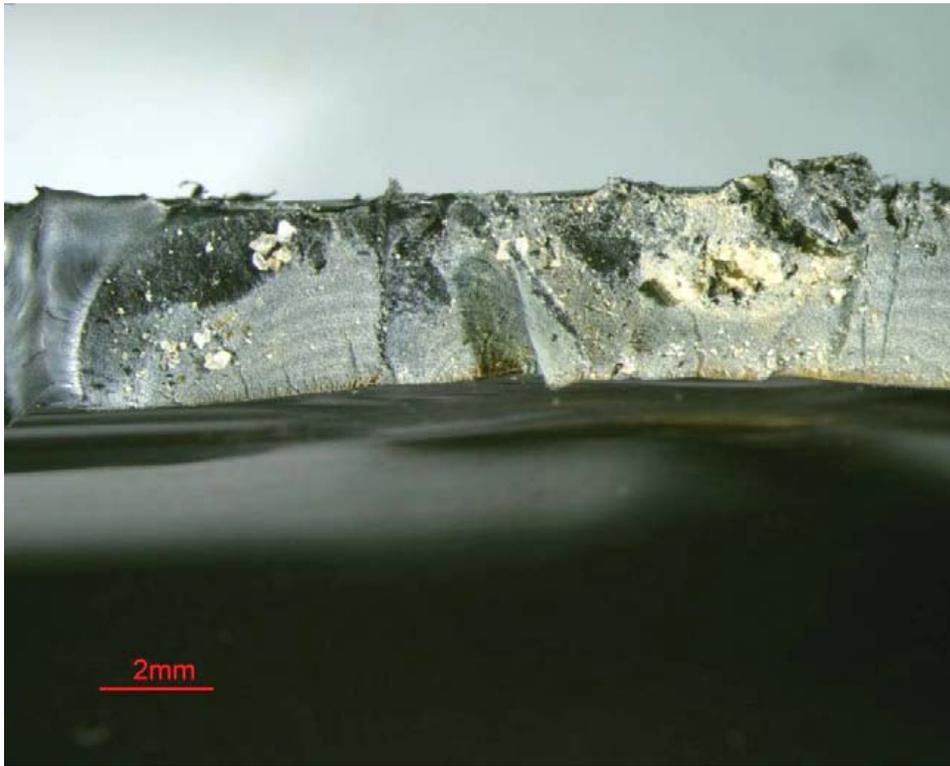
Figure 25. Multiple fracture origins along I.D. at squeeze-off location.

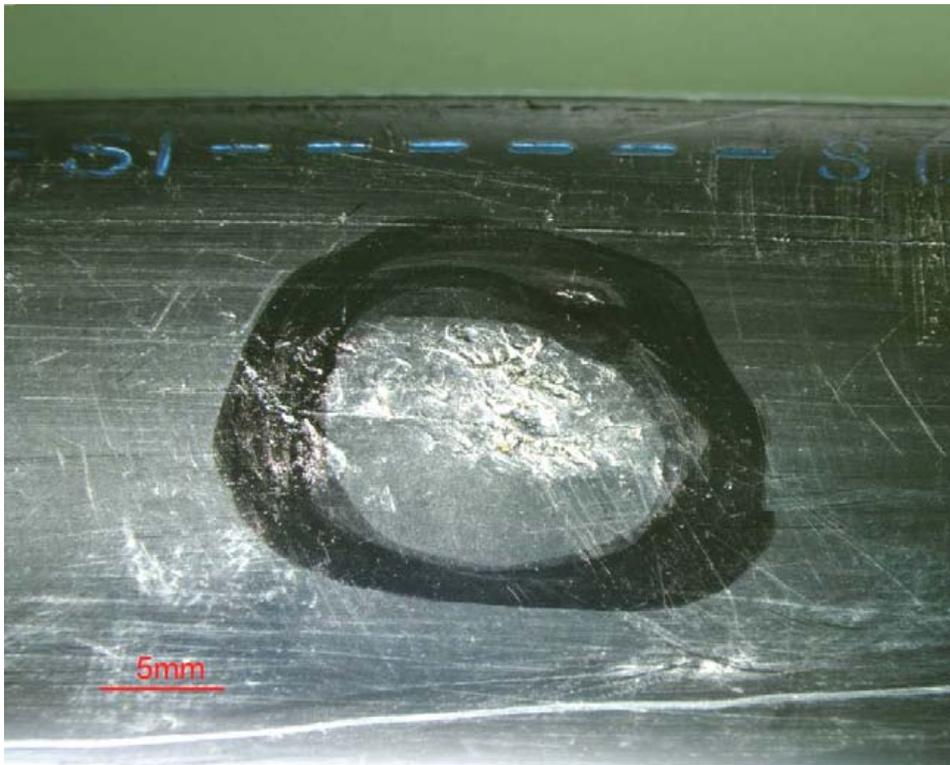
Figure 26. Failure location with outer surface deformation – Bakersfield sample.
