**Oxidative Degradation of High Density Polyethylene Pipes from
Exposure to Drinking Water Disinfectants**

ESI File No.: 29261A

Impact of Polyethylene Pipe Oxidative Degradation on Pipeline Performance:
A Literature Review – Section I

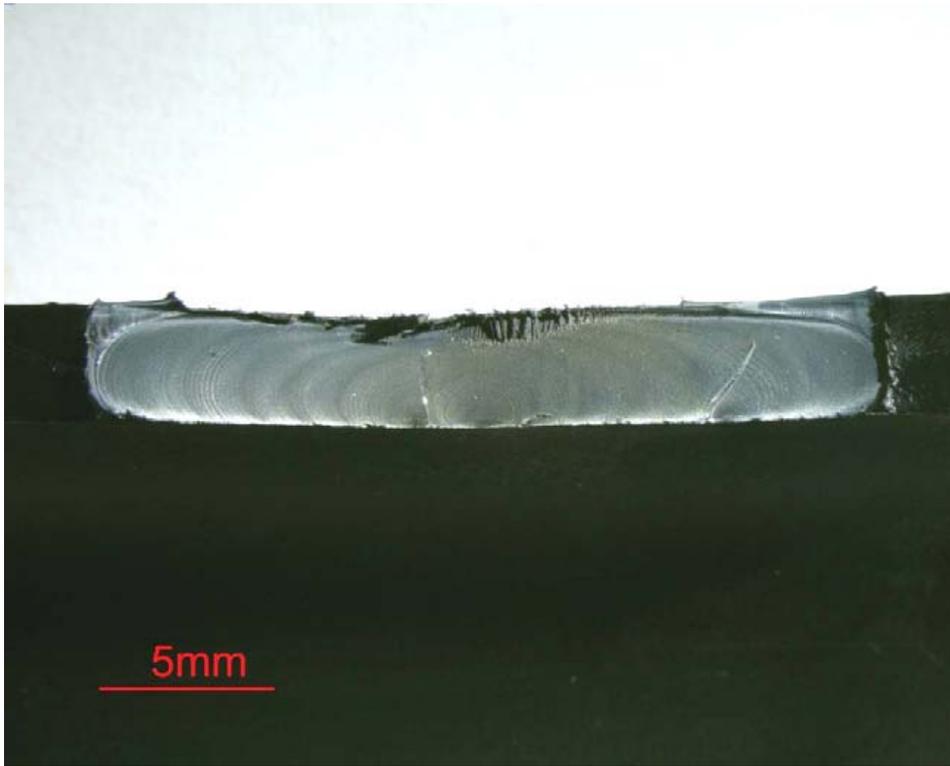
Figure 27. Overall fracture surface from Figure 26 – Bakersfield sample.

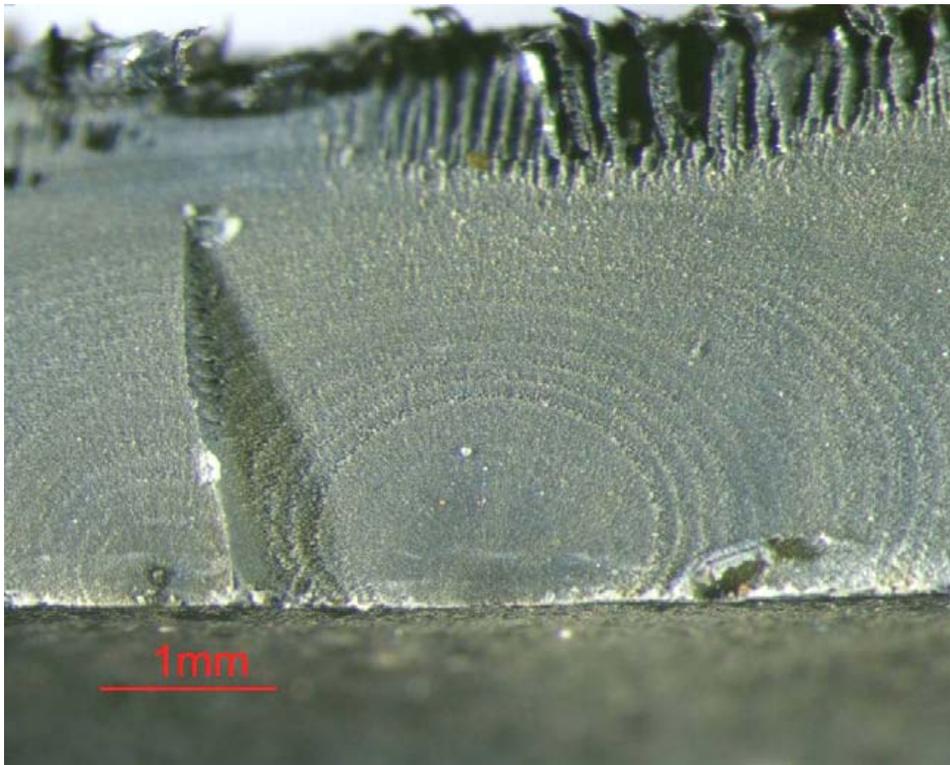
Figure 28. Close-up of fracture origins from Figure 27 – Bakersfield sample.

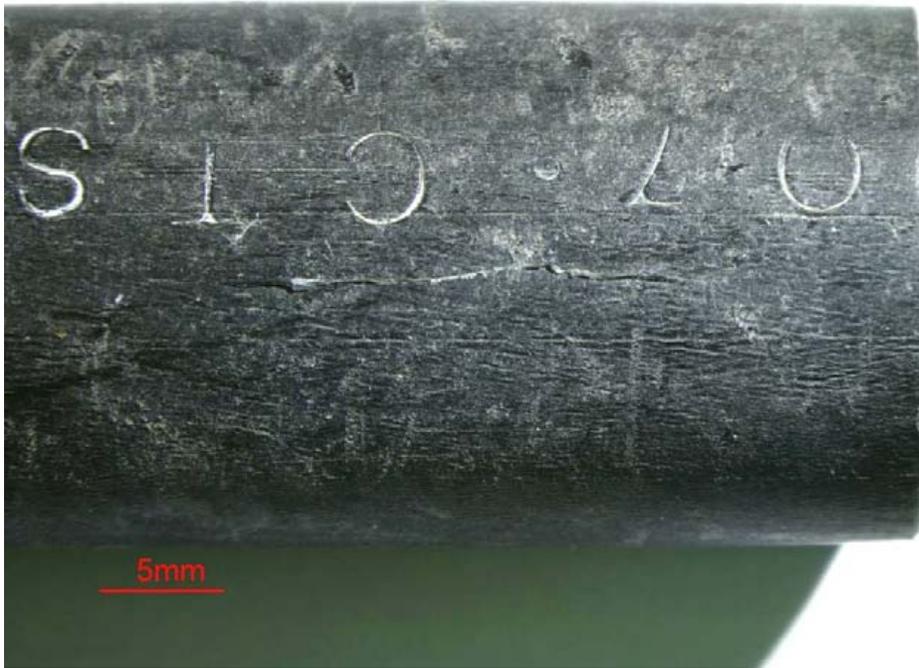
The samples from Hamilton, Ohio all exhibited intense oxidation at the inner surface. These samples failed after service times of from 1 to 12 years. This oxidation was limited to the first 2 mils, but did lead to crack initiation and failure in many instances. The Hamilton, Ohio location was the only one where chlorine dioxide was used as a water disinfectant.

Figure 29. Hamilton, OH sample with longitudinal split.

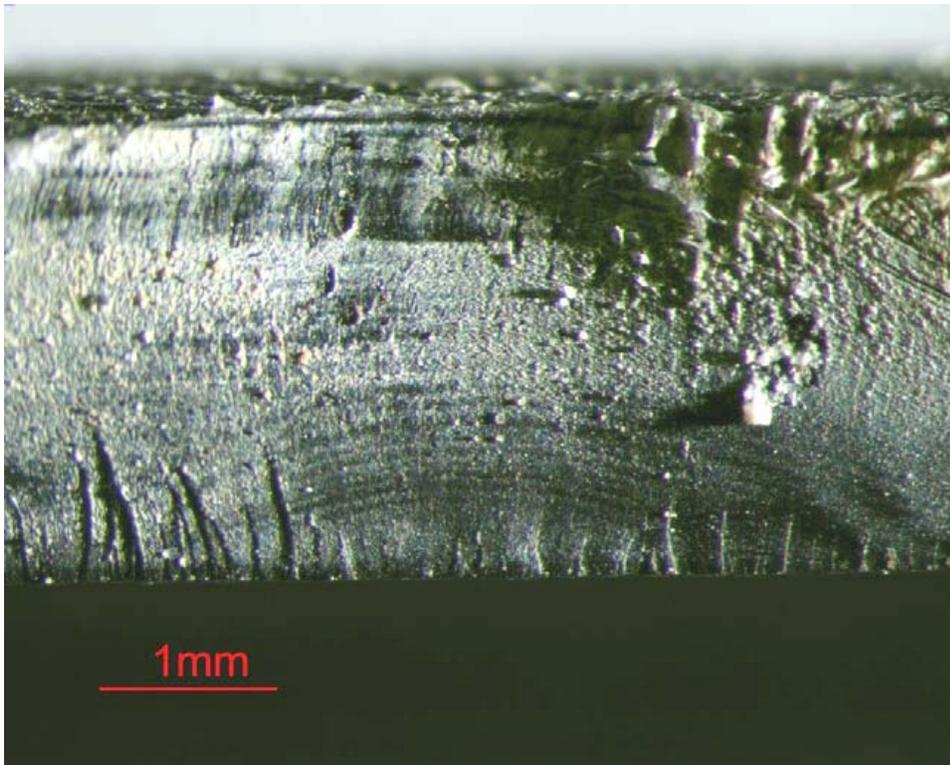
Figure 30. Fracture surface from Hamilton, OH sample from Figure 22 showing brittle fracture initiation along the oxidized inner pipe wall.

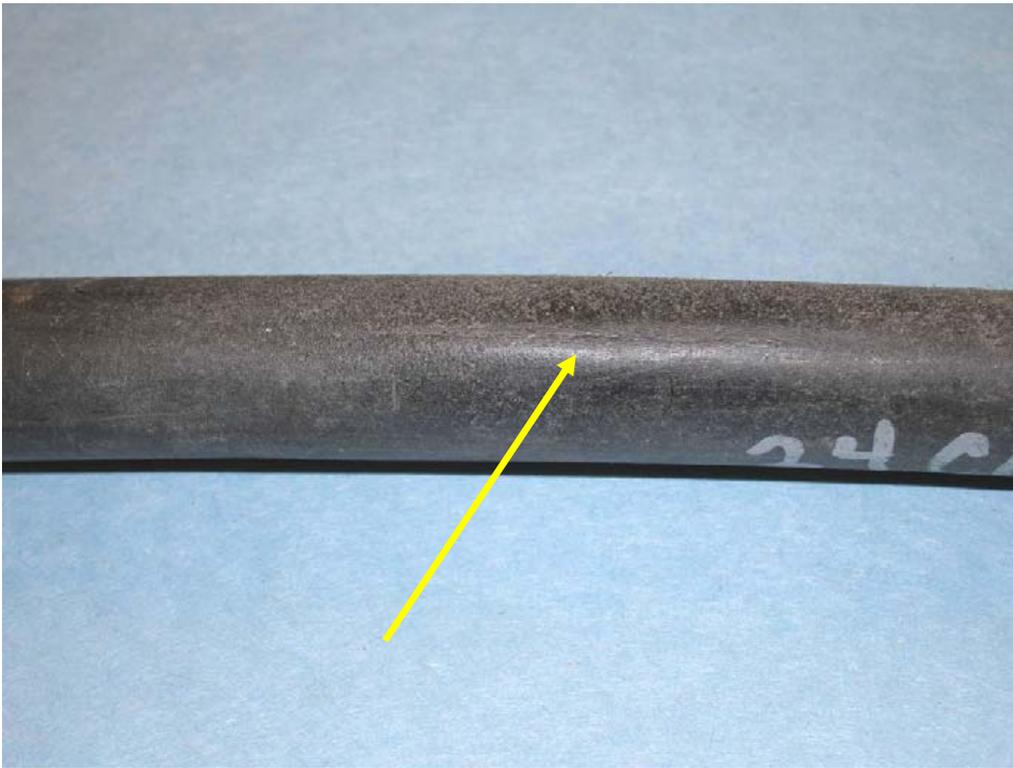
Figure 31. Second Hamilton, OH sample with longitudinal split.

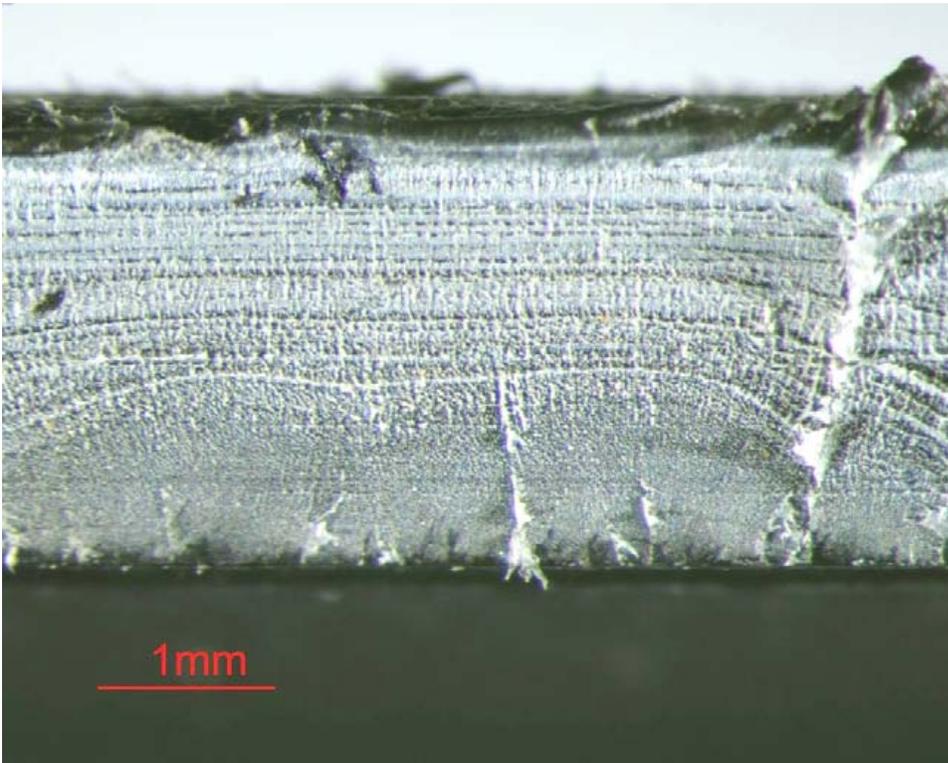
Figure 32. Fracture surface from sample in Figure 24.

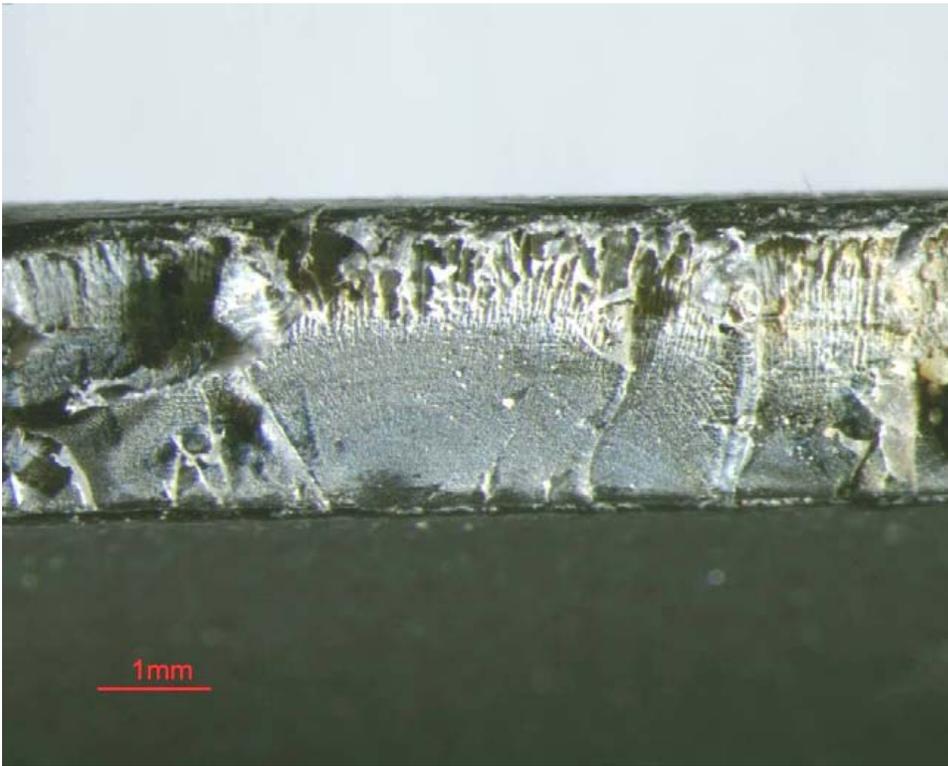
Figure 33. Fracture surface from additional Hamilton, OH sample.

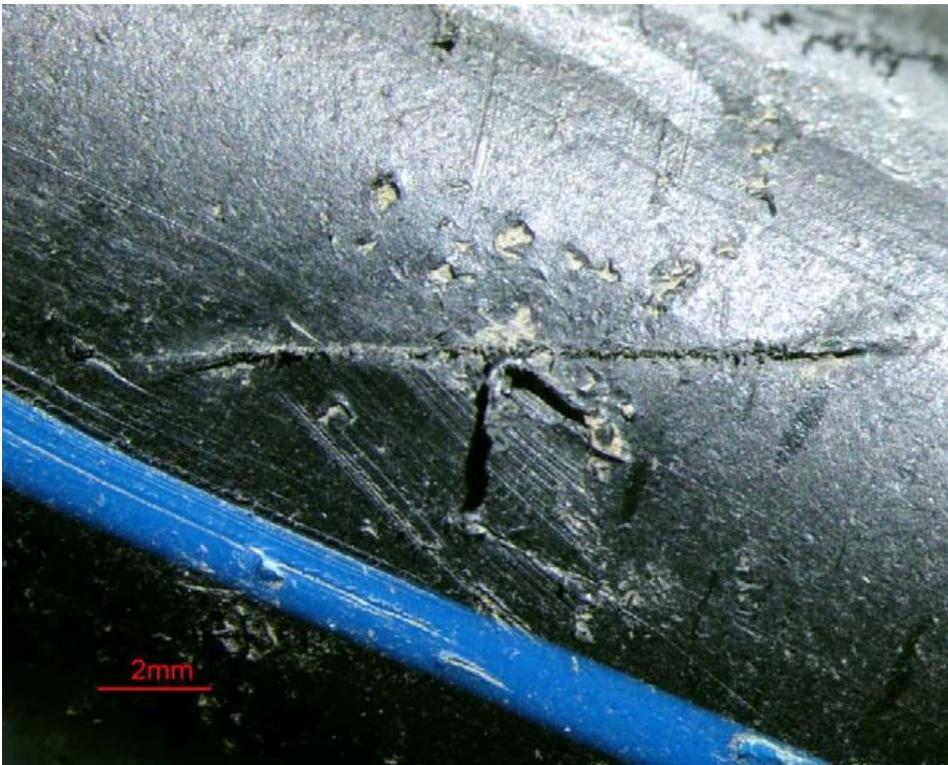
Figure 34. Failure area from Hamilton, OH showing deformation of outer surface.

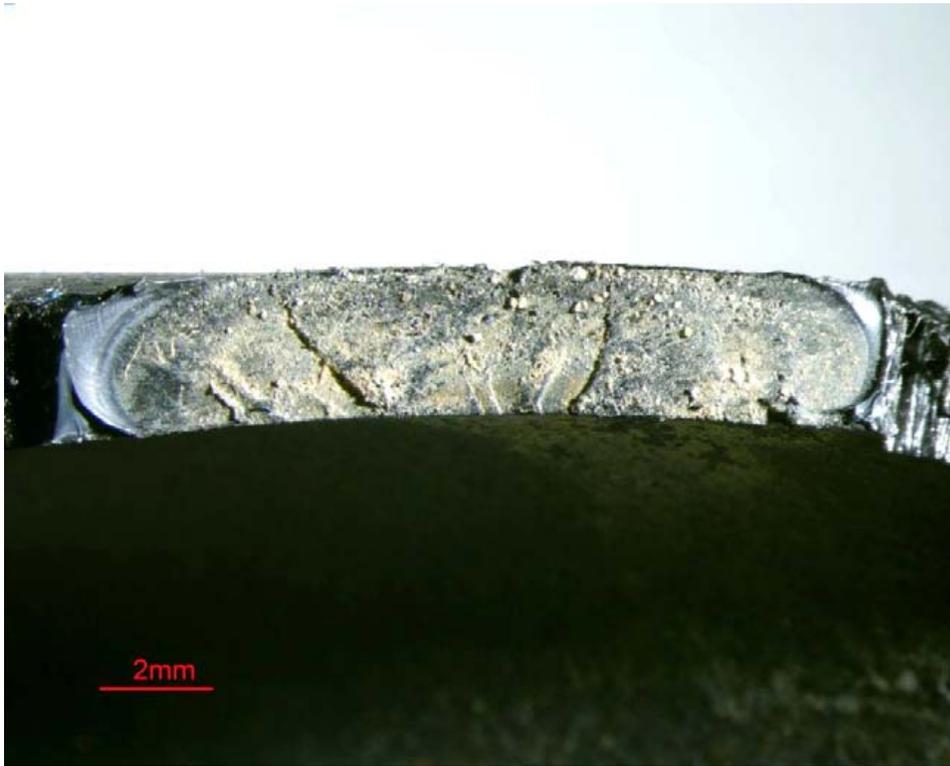
Figure 35. Fracture surface from Figure 27.

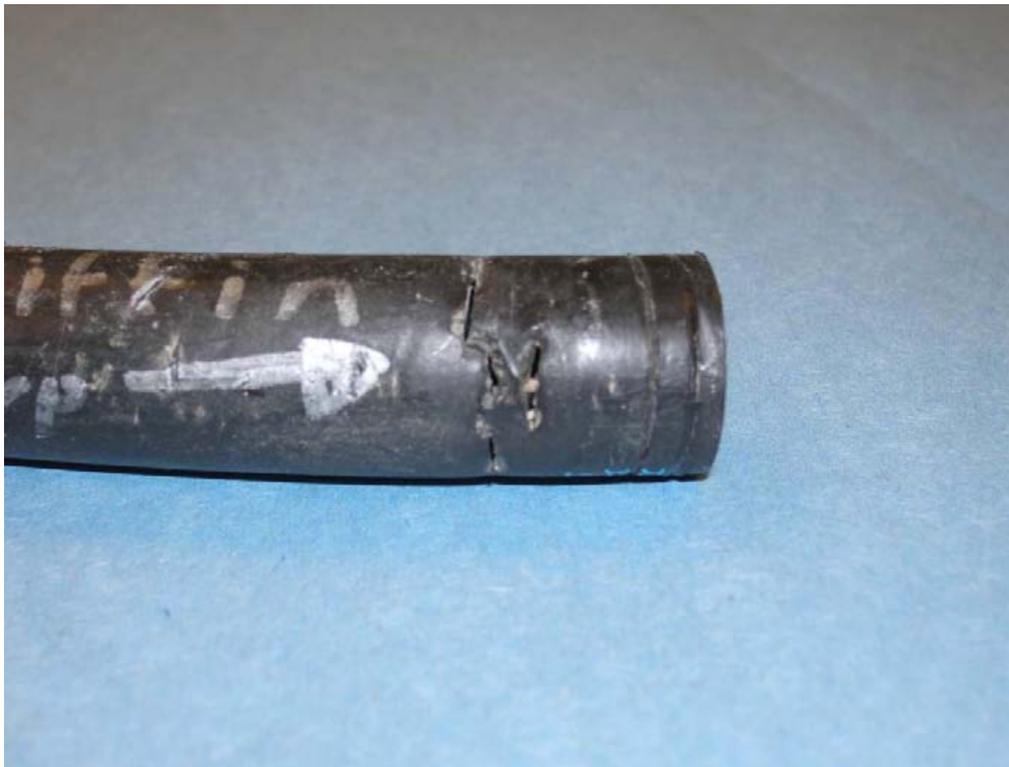
Figure 36. Failure at fitting – Hamilton, OH sample.

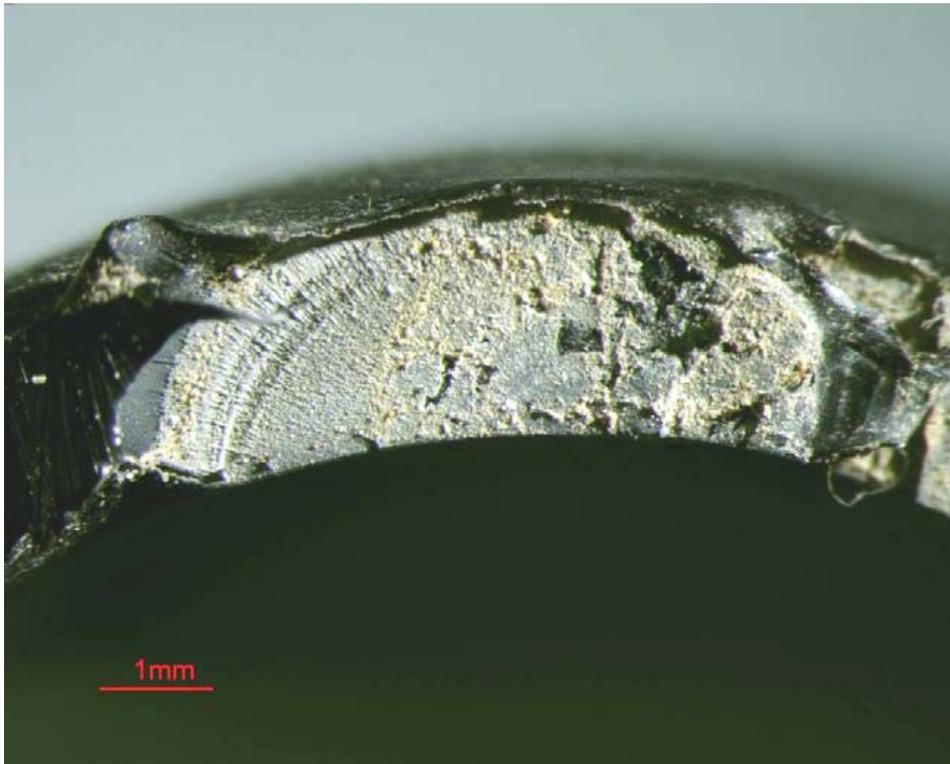
Figure 37. Fracture surface from Figure 29 showing slow crack growth failure due to bending at fitting.
