**Oxidative Degradation of High Density Polyethylene Pipes from
Exposure to Drinking Water Disinfectants**

ESI File No.: 29261A

Impact of Polyethylene Pipe Oxidative Degradation on Pipeline Performance:
A Literature Review – Section I

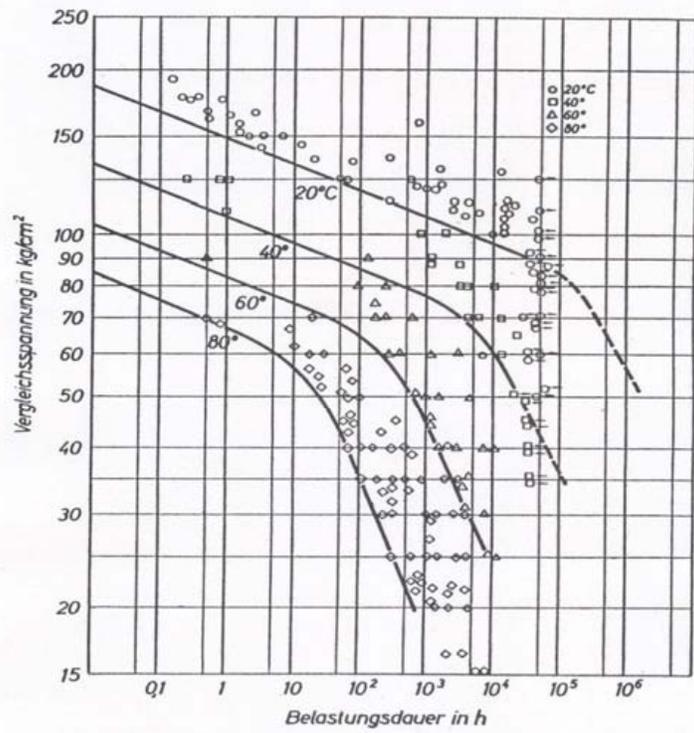
Figure 1: Pipe hoop stress vs. time to leak data for HDPE pipe (Ref. 3)

Fig. 6. Creep rupture strength curves (minimum values) of Ziegler polyethylene pipes for 20°, 40°, 60° and 80° C.

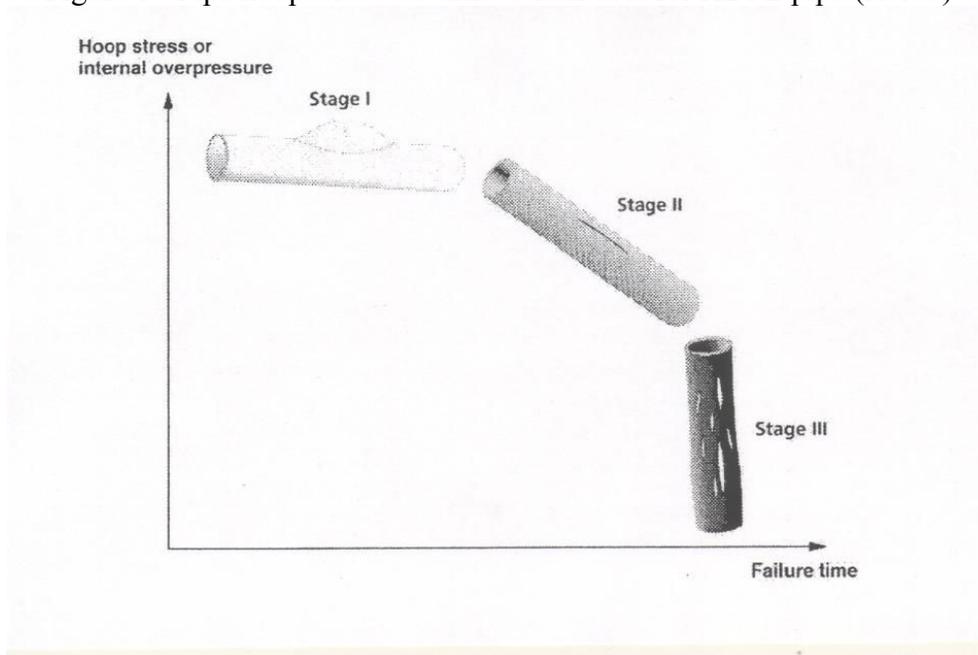
Figure 2: Three stages of creep rupture failure in HDPE pipe.

The polyethylene pipe industry has recognized for many years that oxidation-controlled failure of HDPE pipe does occur. The impact of this is depicted on the schematic creep-rupture curve in Figure 2. The two stages of mechanical failure manifested in pipe testing results as depicted in Figure 1 (Stage I and Stage II) are now joined by a third stage of oxidation-controlled failure (Stage III). Note that the line representing Stage III failure is very steep, indicating that once oxidation of the pipe material becomes the rate controlling step in pipe failure the level of stress in the pipe becomes much less of a factor in failure time – and pipe end-of-life occurs relatively quickly.

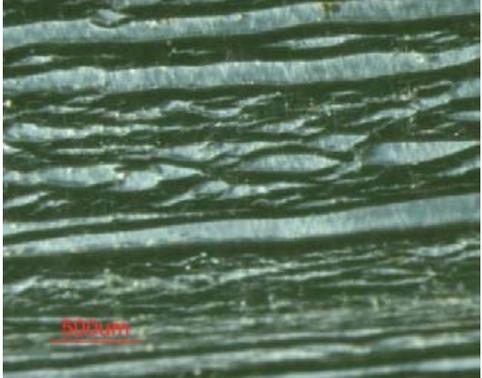
Sample	Service Time, years	Bend Back Test Result
Virgin Valley NV 1" SDR9 Mfg- Vanguard OIT: 3.37 ■ CI (ATR): 0.102 ■ CI (T): 0.265 ■	6.00

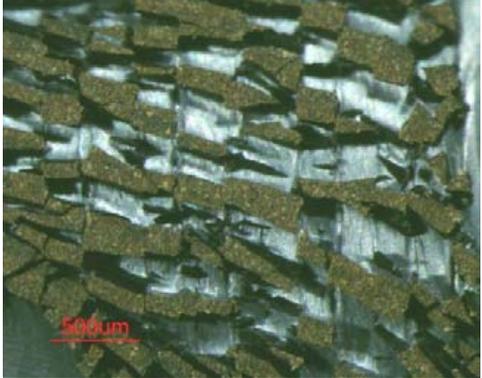
Maui HI 1" Nominal, 0.28" wall Mfg – Driscopipe OIT: 0.30 min ■ CI (ATR) : 0.092 ■ CI (T) : 0.182 ■	11.00

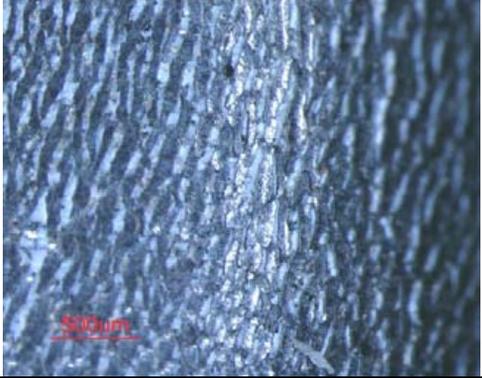
Makawao Maui HI- 1" Sample 1 1" DR9 Mfg - Driscopipe OIT: 1.93 ■ CI (ATR): 0.116 ■ CI (T): 0.174 ■	13.01

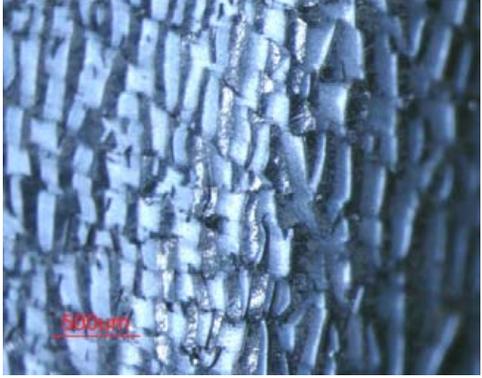
Makawao Maui HI - 1.25" Sample 2 1.25" DR9 Mfg – Driscopipe OIT: 1.83 ■ CI (ATR): 0.217 ■ CI (T): 0.157 ■	13.01

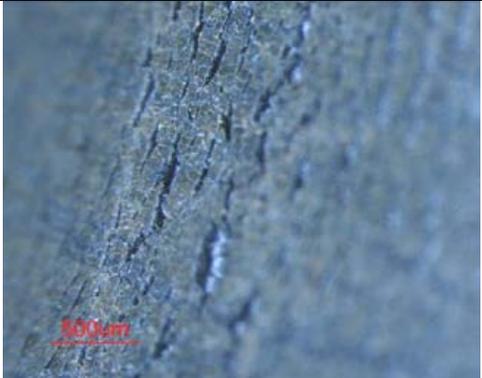
Sample	Service Time, years	Bend Back Test Result
Central Maui HI – Sample 3 1.25" DR9 Mfg – Driscopipe OIT: 2.94 ■ CI (ATR): 0.202 ■ CI (T): 0.003 ■	17.07

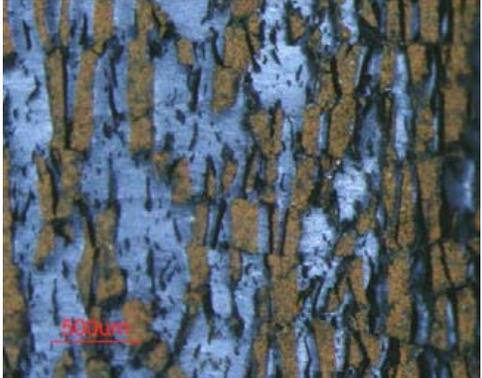
Kula Maui HI - 2" Sample 4 2" DR9 Mfg – Driscopipe OIT: 0.48 ■ CI (ATR): 0.228 ■ CI (T): 0.170 ■	11.02

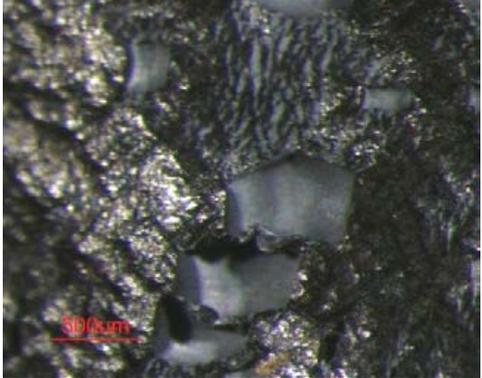
One of the pipe samples, Sample 6, from Ocoee, TN exhibited a high inner surface OIT (17.06 minutes) while failing the bend back test and exhibiting a high carbonyl index by ATR-FTIR. This particular pipe is a 6-inch pipe with a thicker wall than most of the pipes included in the study. The core OIT is very high (73.6 minutes) and it is evident that the anti-oxidant migrated to the surface after the pipe was removed from service. This pipe exhibited cracking at several locations around the circumference of the pipe inner wall and had failed in service. The fracture surface for this sample is examined below in the Fracture Analysis section.

Ocoee TN 6" DR17 Mfg – Polypipe OIT: 17.04 ■ CI (ATR): 0.179 ■ CI (T): 0.006 ■	5.00

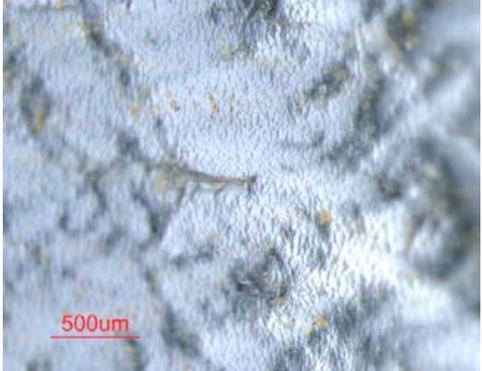
West Maui Land – Maui HI 4" DR13.5 Mfg – Plexco OIT: 7.8 ■ CI (ATR): 0.099 ■ CI (T): 0.002 ■	10.00

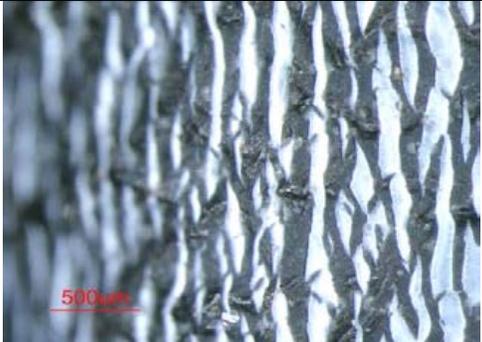
Sample	Service Time, years	Bend Back Test Result
West Maui Land Sample 2 6" DR11 Mfg – Plexco OIT: 0.20 ■ CI (ATR):0.101 ■ CI (T): 0.207 ■	8.00

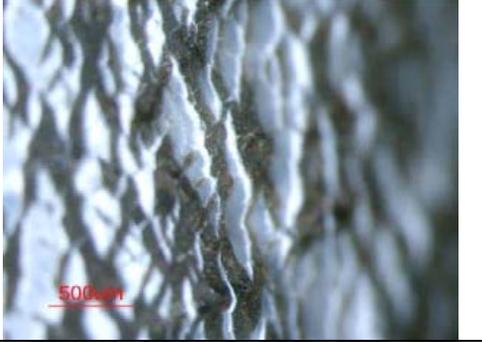
West Maui Land #3 6" DR9 Mfg – Polypipe OIT: 33.8 ■ CI (ATR): 0.019 ■ CI (T): 0.007 ■	7.00	NA – Sample too small
West Maui Land Sample 4 6" DR9 Mfg – Plexco OIT: 0.20 ■ CI (ATR): 0.200 ■ CI (T): 0.100 ■	8.00

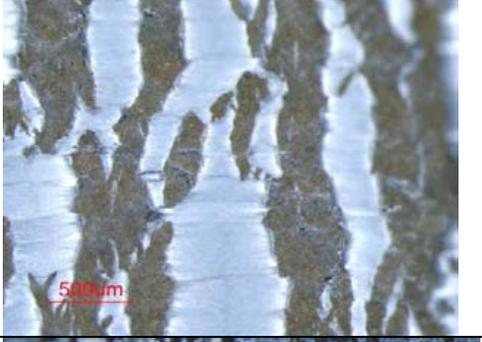
Lafayette LA 6" Mfg – ? OIT: 0.90 ■ CI (ATR): 0.107 ■ CI (T): 0.200 ■	12.00

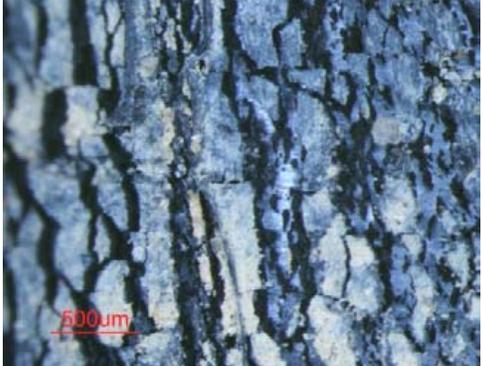
HB&TS ¾" DR9 Mfg – Driscopipe OIT: 0.20 ■ CI (ATR): 0.503 ■ CI (T): 0.413 ■	25.04

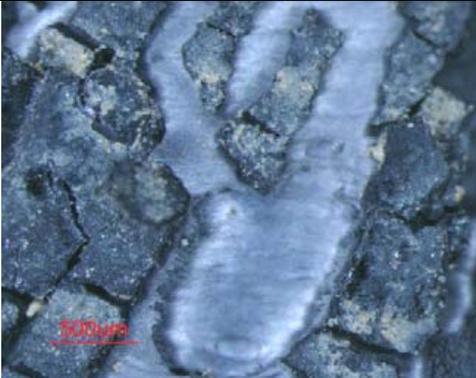
Sample	Service Time, years	Bend Back Test Result
HB&TS 3/4" DR9 Mfg – Yardley OIT: 0.20 ■ CI (ATR): 0.449 ■ CI (T): 0.310 ■	25.04

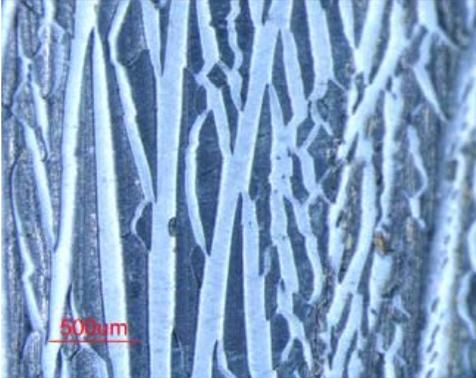
Pomona CA 3/4" Mfg – Orangeburg OIT: 0.30 ■ CI (ATR): 0.154 ■ CI (T): 0.182 ■	28.00

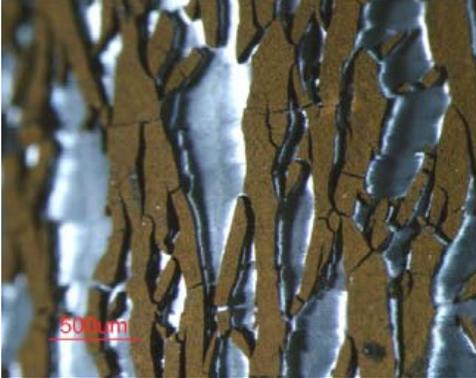
Laughlin NV 3711 Westcliff 1" Mfg – UNK OIT: 0.40 ■ CI (ATR): 0.128 ■ CI (T): 0.306 ■	25.2

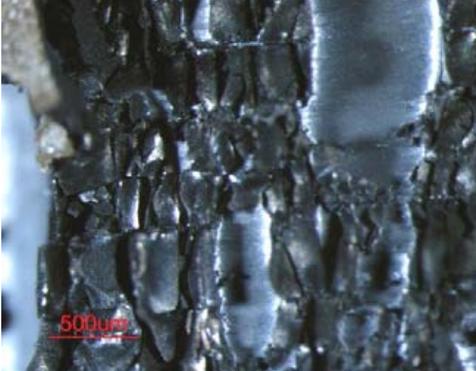
Laughlin NV 1817 Oasis 1" Mfg – UNK OIT: 0.10 ■ CI (ATR): 0.450 ■ CI (T): 0.420 ■	22.10

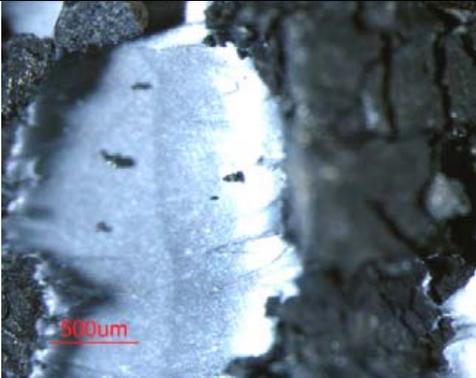
Sample	Service Time, years	Bend Back Test Result
Laughlin NV 1818 Oasis 1" Mfg – UNK OIT: 0.80 ■ CI (ATR): 0.280 ■ CI (T): 0.250 ■	22.00

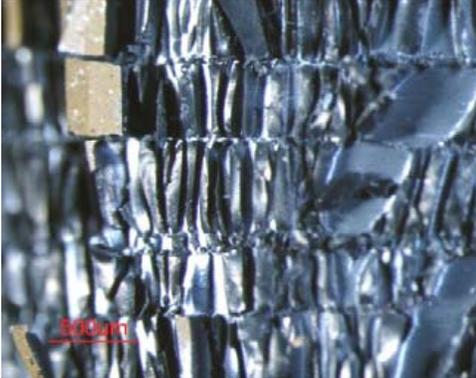
Laughlin NV 3332 Calanda 1" Mfg – UNK OIT: 0.20 ■ CI (ATR): 0.238 ■ CI (T): 0.449 ■	25.50

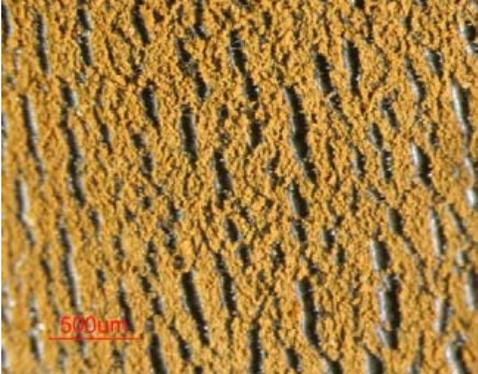
Sample	Service Time, years	Bend Back Test Result
Bakersfield CA Sample 5 – 7708 N. Laurelglen Blvd. 1” Mfg – UNK OIT: 0.50 ■ CI (ATR): 0.085 ■ CI (T): 0.061 ■	31.03

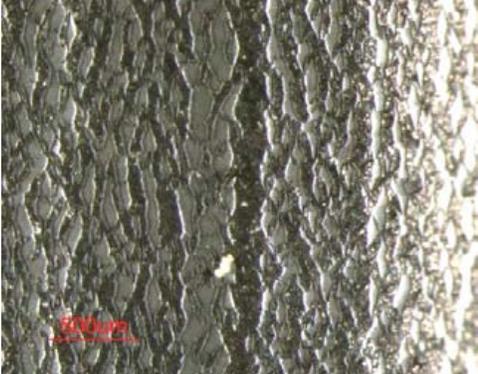
Bakersfield CA Sample 6 – 12402 Woodson Bridge Dr 1” DR9 PE 3408 Mfg – Wesflex OIT: 2.70 ■ CI (ATR): 0.081 ■ CI (T): 0.012 ■	7.09
